Project Case Study Green Rivers Manor Beijing, PR China

December 2009

Hydrotech Asia Limited and Hydrotech China Company Limited herein referred to as "Hydrotech", were appointed by the Owner of the Green Rivers Manor location at Block 39 Lot 17 to provide water ingress solution to existing water dampness at the basement of the property.

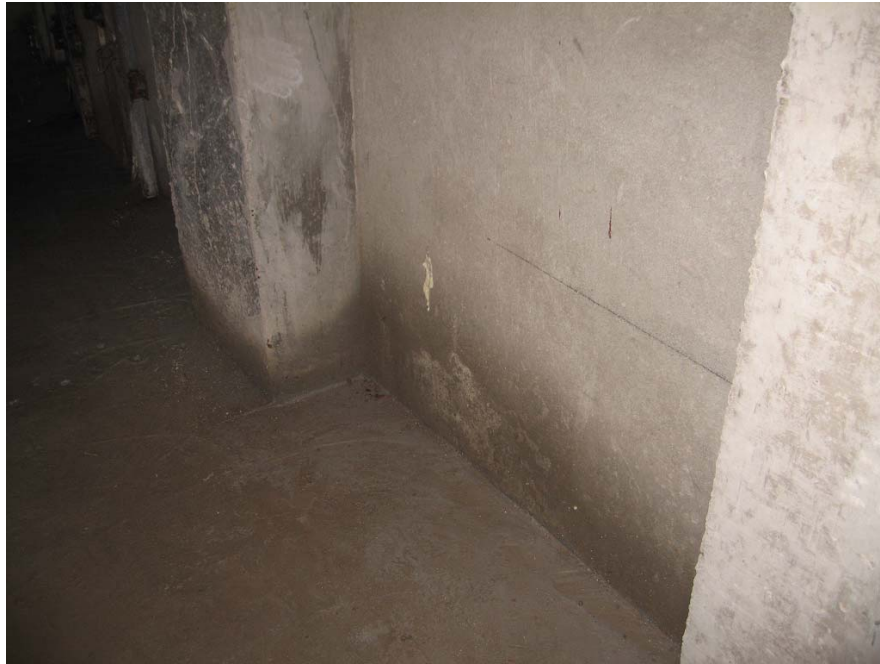
The Green Rivers Villa was just completed in 2008 and suffers from water ingress and raising damp on external walls, internal partition walls, floors slab and interior columns within the basements, refer to photos below.

Initial Conditions of Exterior Walls

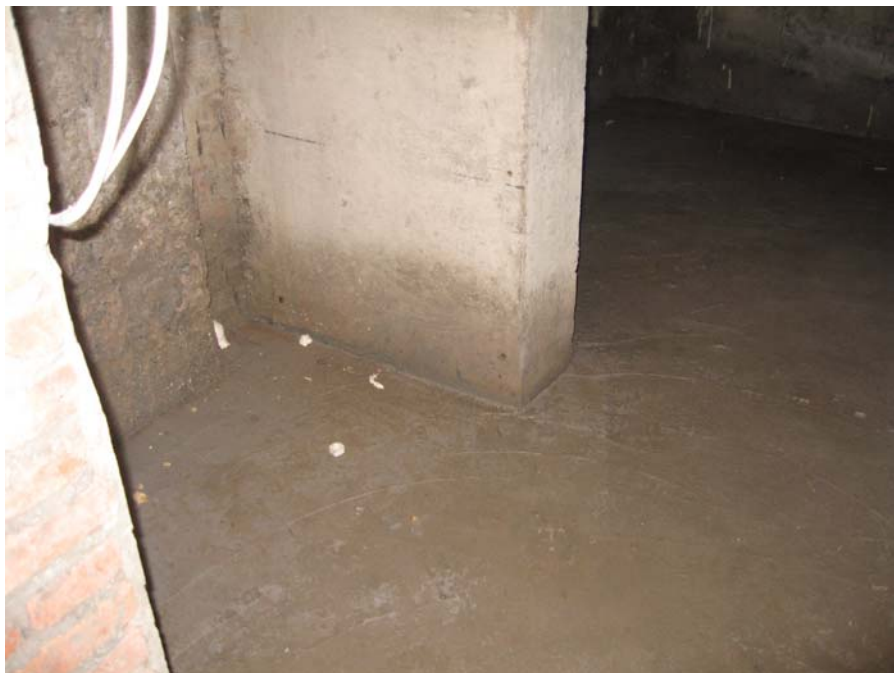
Initial Conditions of Interior Walls

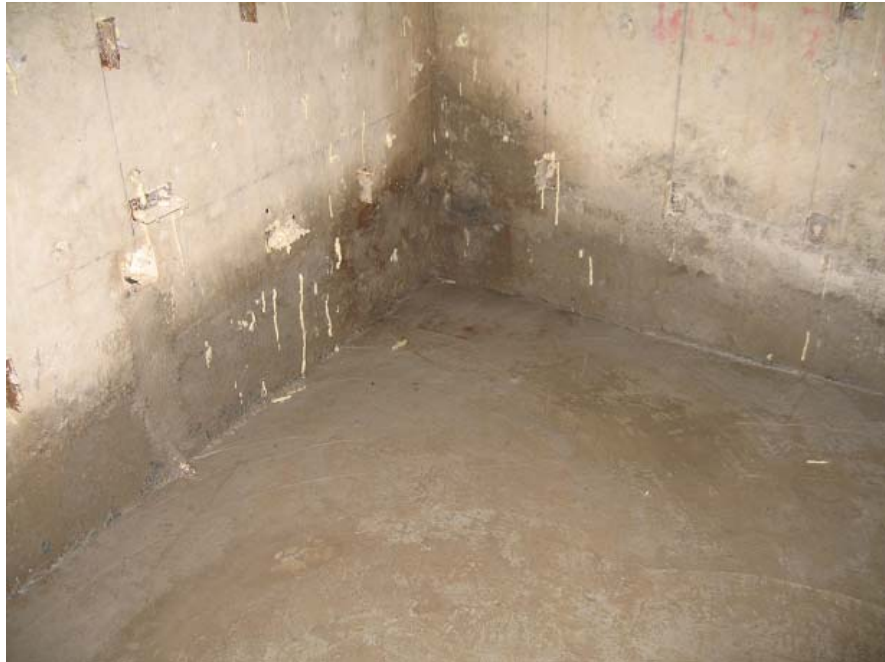
Various measures have been adopted to control the water ingress such as patch repairs and cementitious water proofing coating system was previously adopted to control the dampness but it failed to provide a long-term solution.

Initial Conditions at the corners of Exterior & Interior Walls

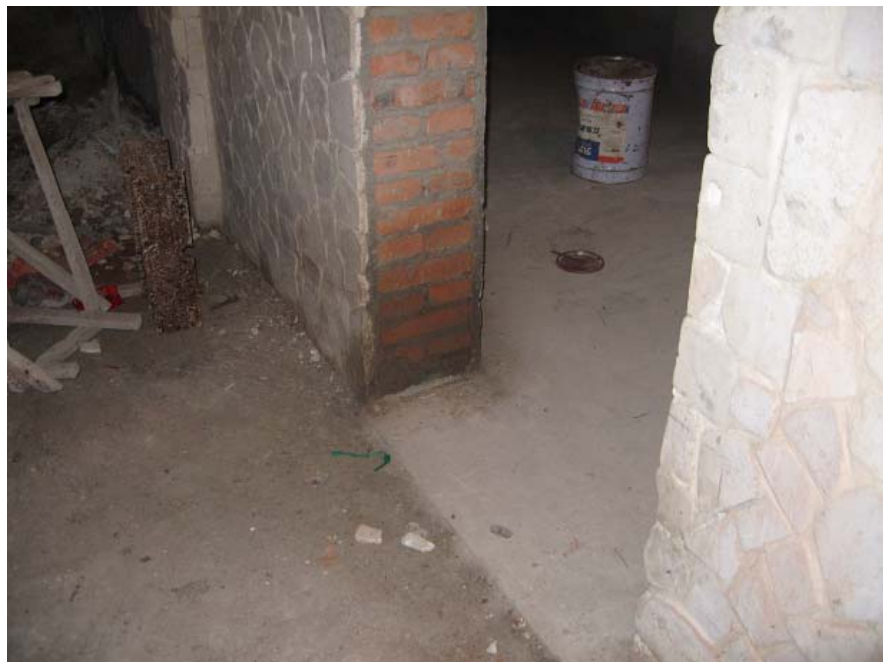
Raising Damp on Interior Brick Wall Partition

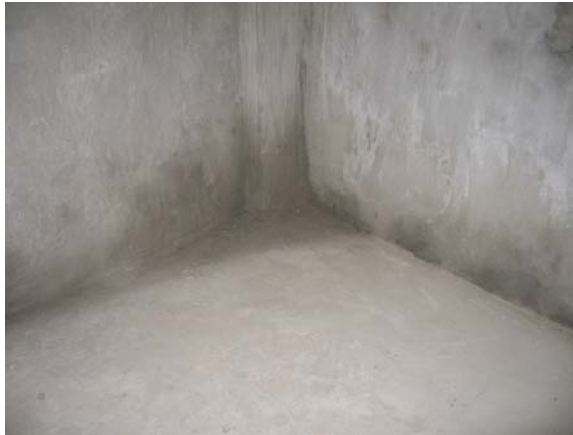
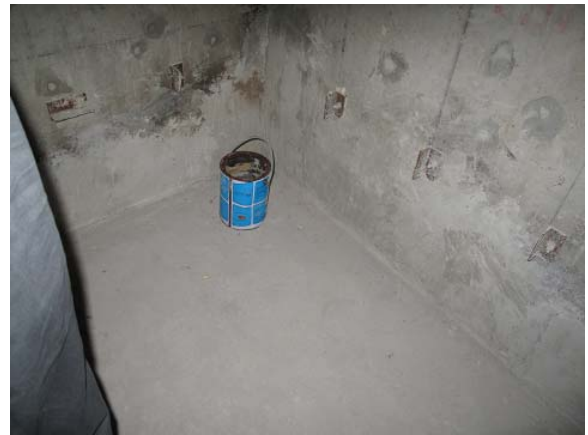
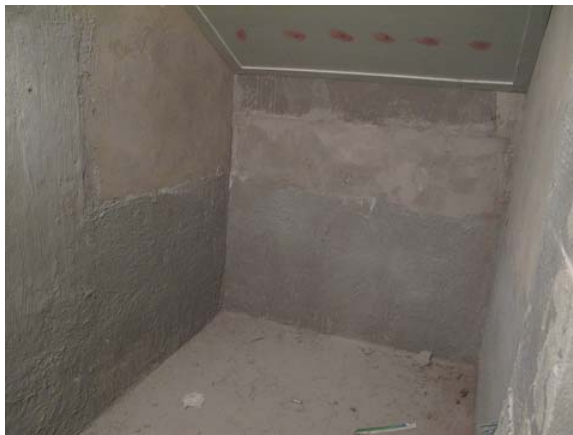
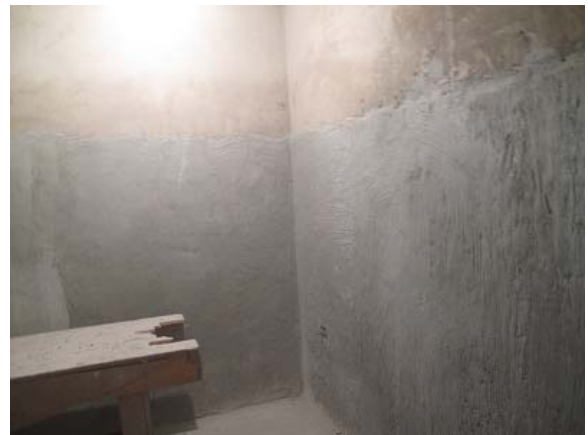
Areas that has been previously repaired but the water seepage was still visible

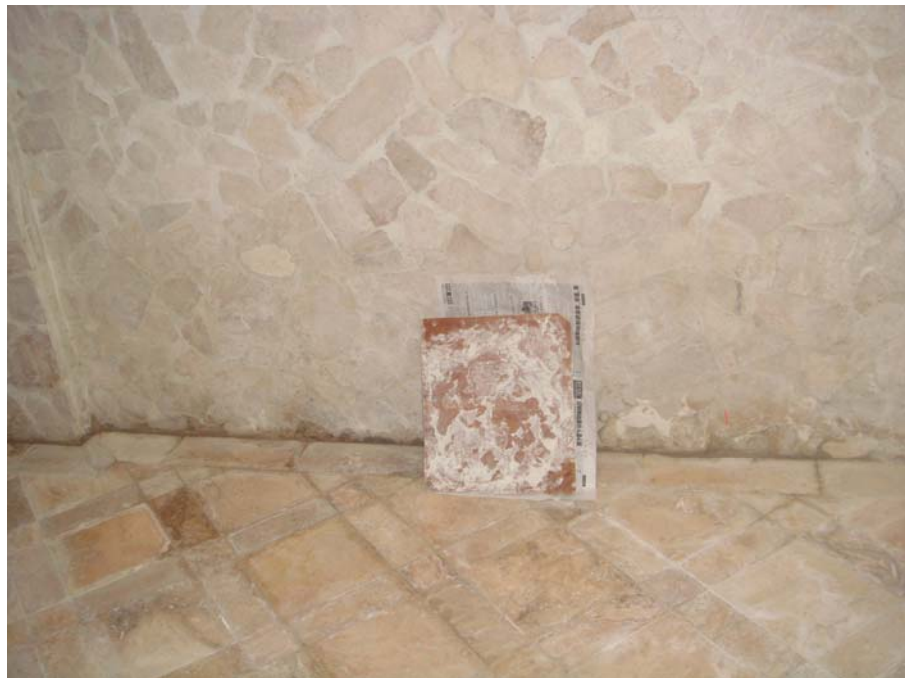
Water seepage at the junction of exterior wall and floor slab
was observed at Block 35 Lot 2

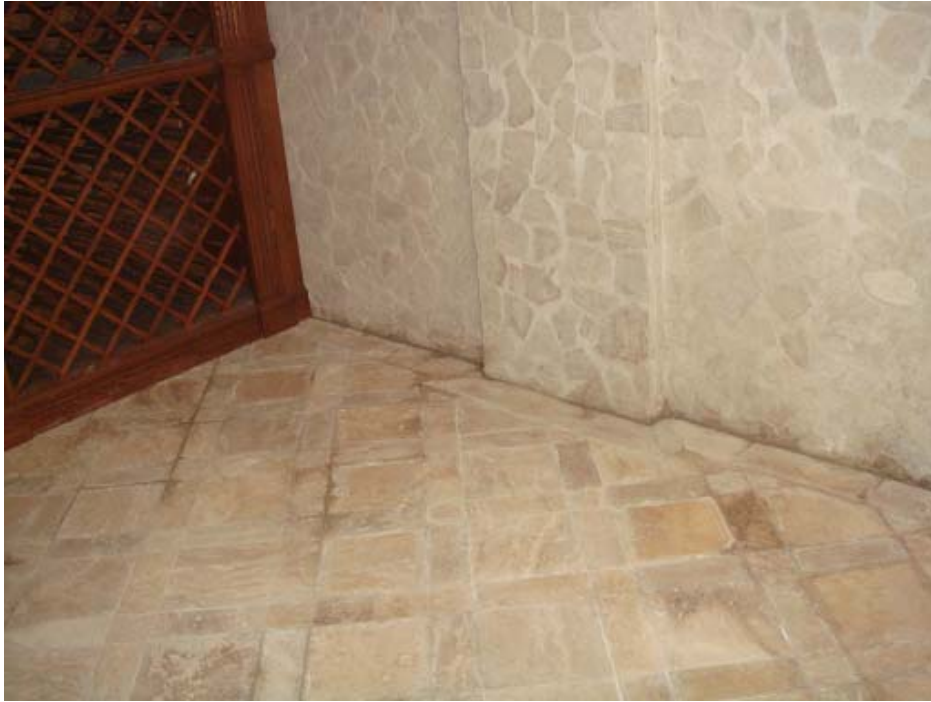
Water seepage was noticed at the junction of columns and floor slab of Block 35 Lot 2 Villa

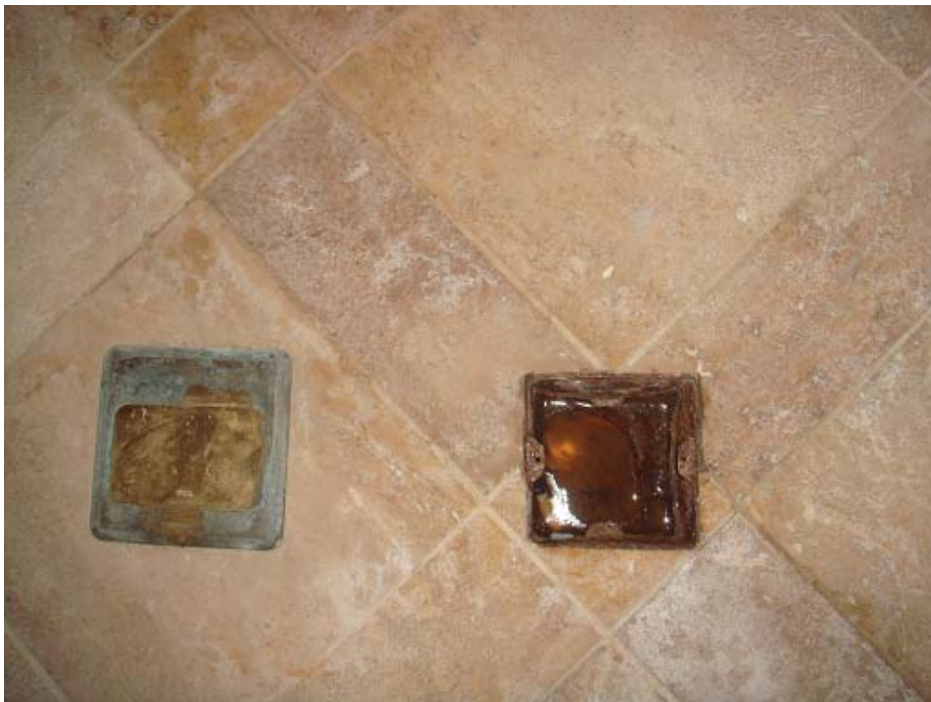
Water ponding was observed inside a damaged electrical floor outlet of Block 35 Lot 2 Villa

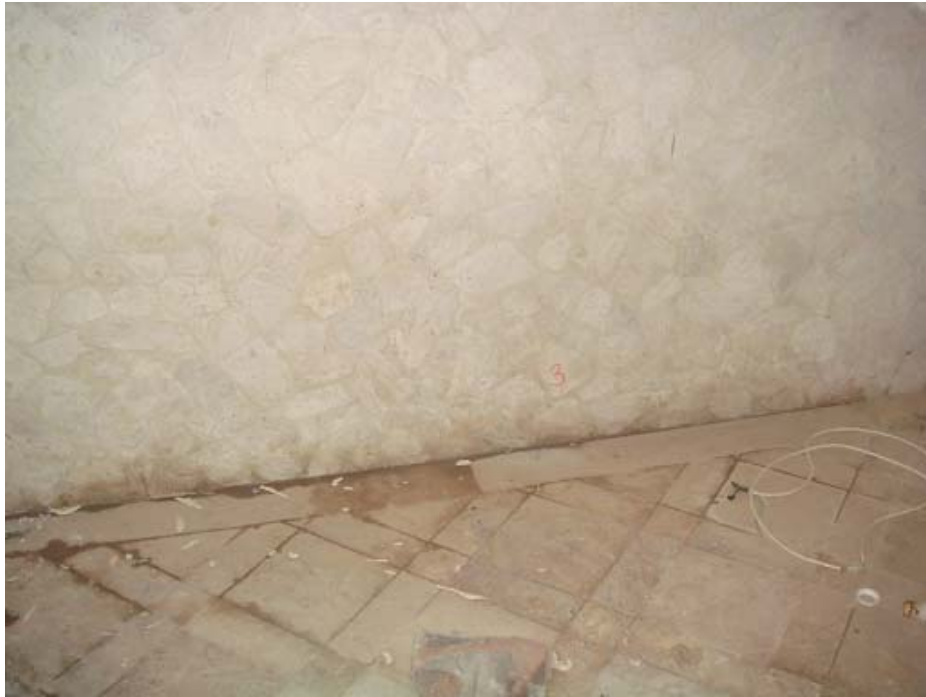
Water seepage was observed at the exterior wall
of Block 35 Lot 2 Villa

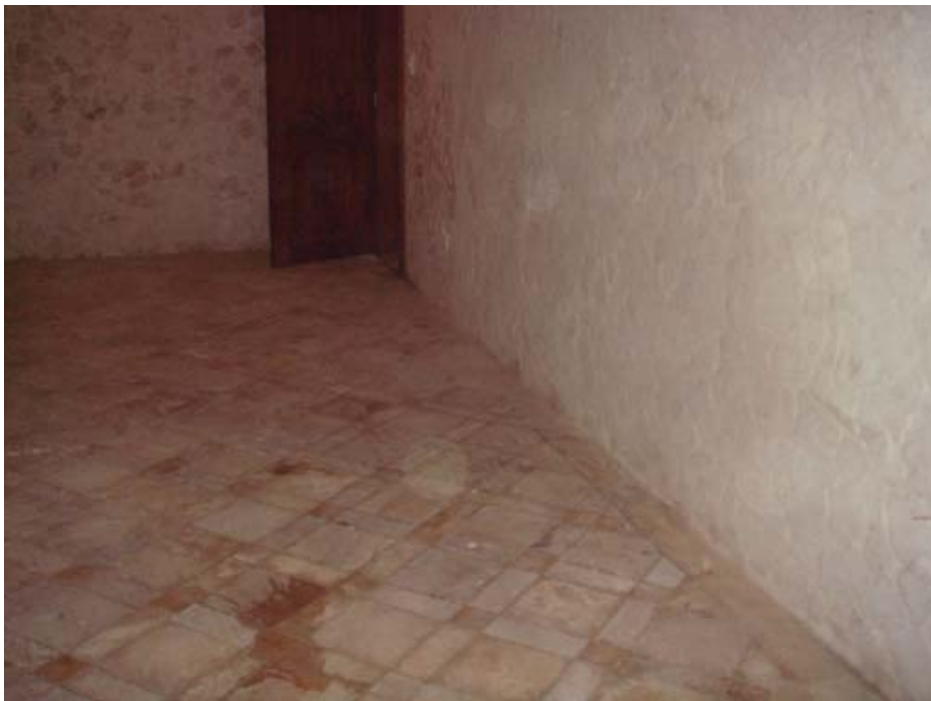
Patches of water was observed at the basement floor slab
of Block 35 Lot 2 Villa

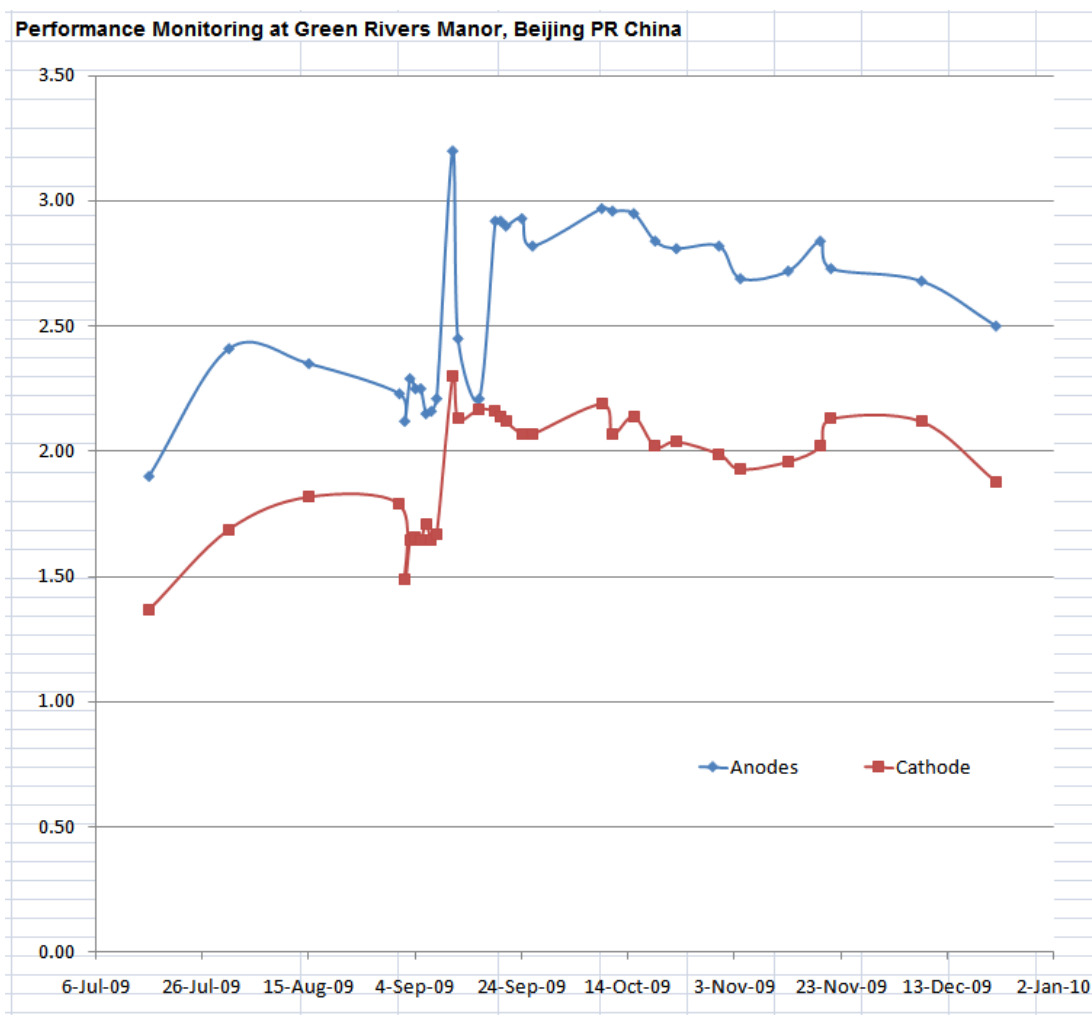
Figure 5

The trends of electrical current are downwards and it is expected that it will continue to go down in the coming months. This graphical result are similar to other successful MPS System installations such as in Walthamstow London Underground Stations, refer to Figure 6.

Whilst in Green Rivers Villa (Figure 5), it is now on its 5th month and it is clearly shown that the drying out process may probably take more or less similar to Walthamstow which is approximately 6th or 7th months to reach its initial dry stage level.

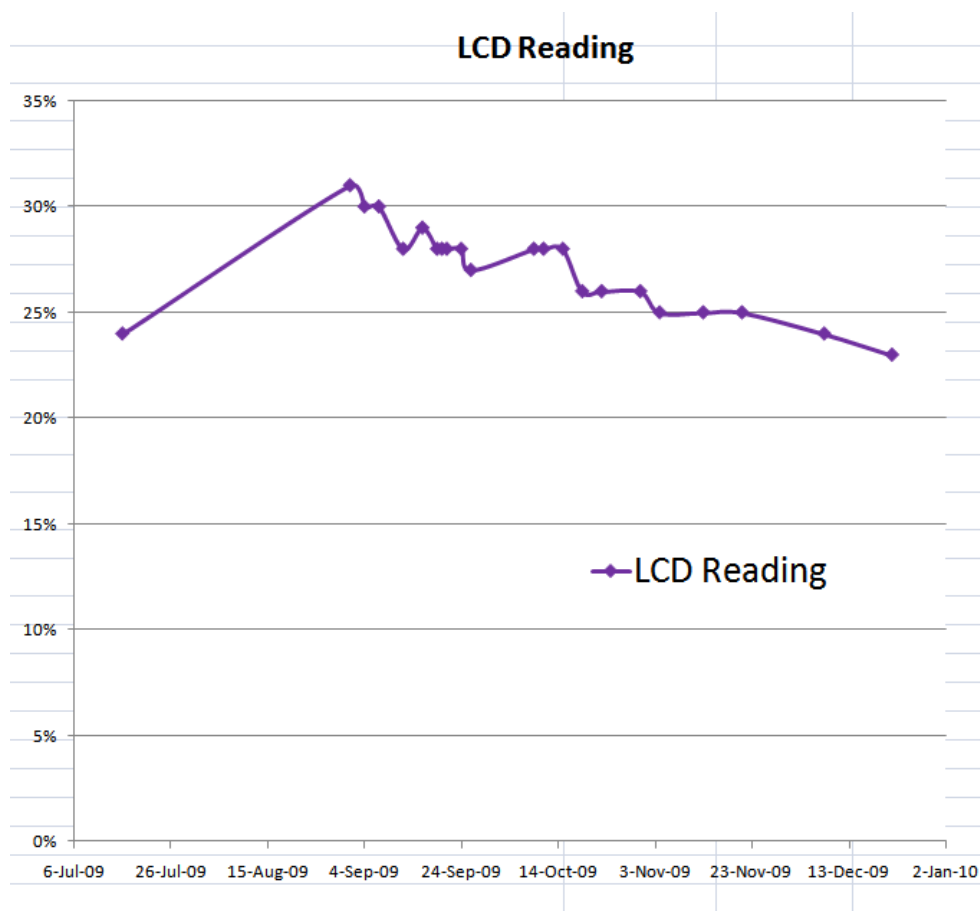
Figure 7

LCD Reading which represents electrical current drawn in the structure has also shown a downward trend. A less electrical current within the concrete structure represents less conductivity, therefore the concrete walls and floor slab are in a continuous drying out process, refer to Figure 7.
