**MPS System Installation
at Tin Ka Ping Lecture Theatre
Hong Kong Institute of Education
10 Lo Ping Road, Tai Po
New Territories, HK**

July 2010

3.0 Problem Statement

5.0 MPS System Design for Tin Ka Ping Lecture Theatre

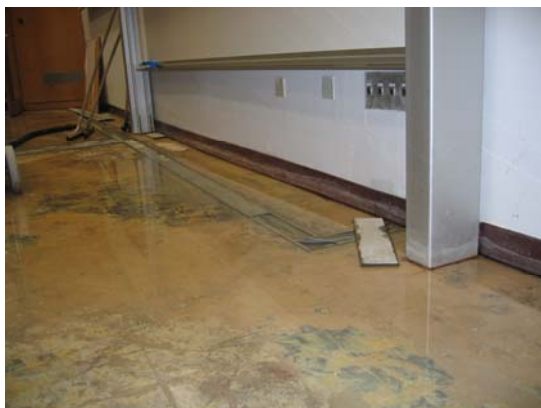
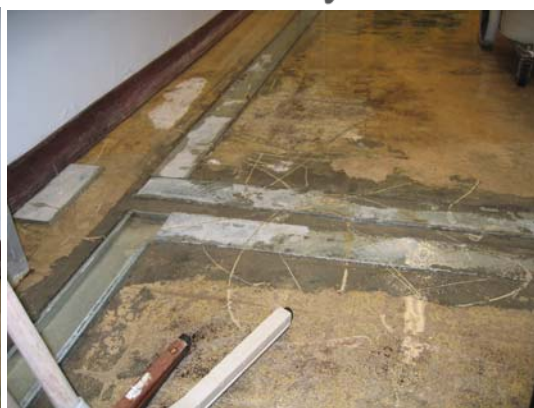
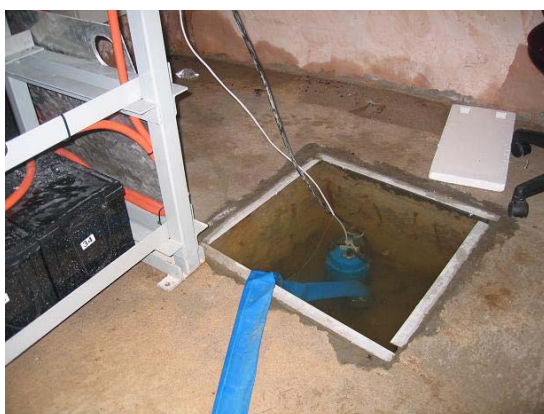
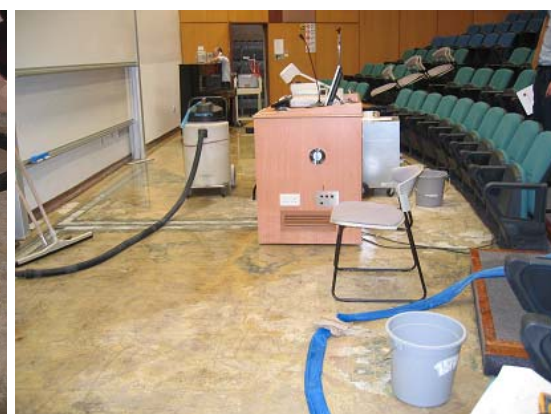
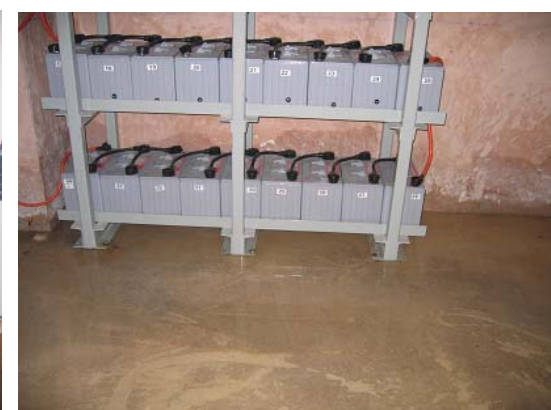
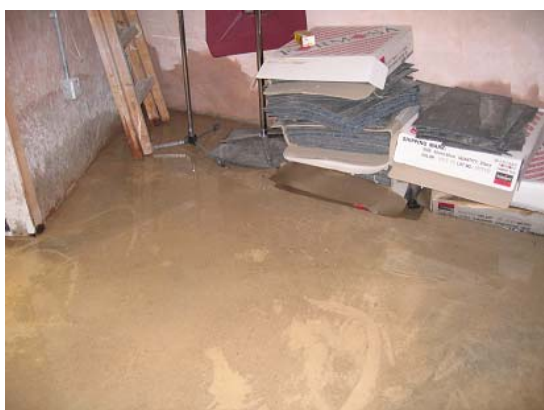
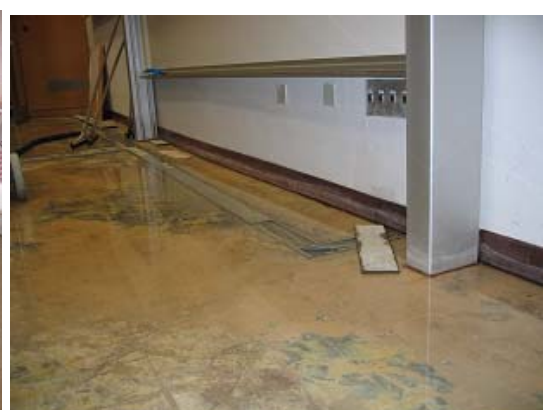
The Theatre was completed in 2004 and suffers from severe water ingress from the lowest level of floor slab through the body of the concrete lining and from the construction joints.

Existing 80mm thick cement/sand screeding layer laid on top of the structural floor slab was observed to be deteriorating. Visible cracks appeared on the surface and de-bonding was observed. Based on the conclusion of Hydrotech’s investigation and recommendations, all screeding layers must be removed, MPS system will be install at the structural layer and screeding will be reinstated with the same thickness and specifications, refer to photos on the following page.

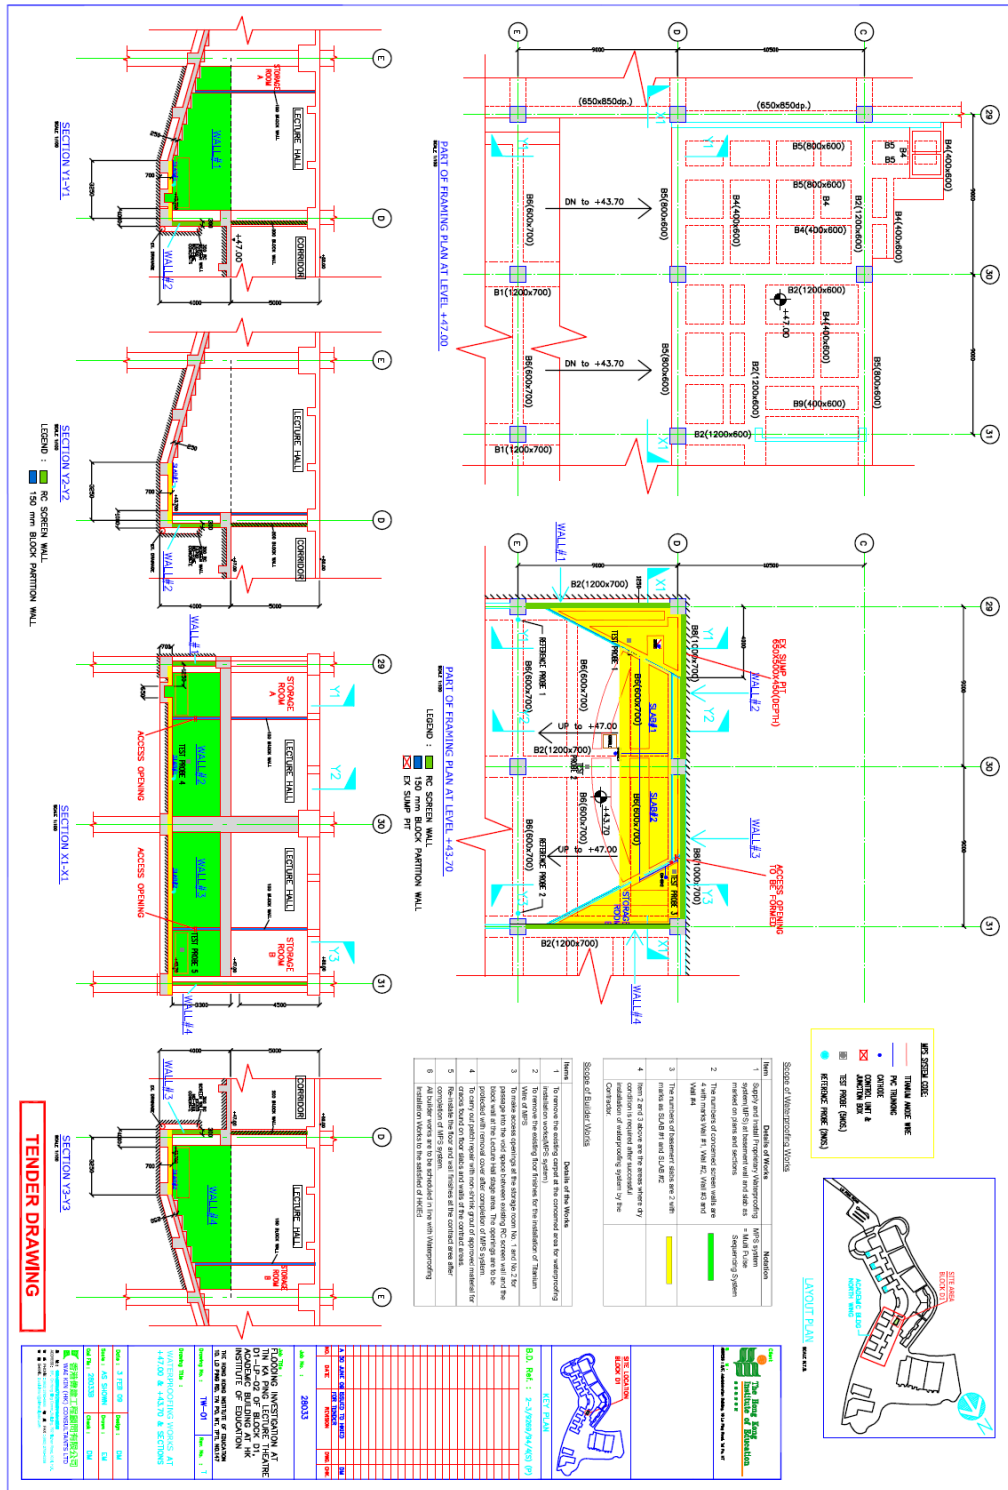
9.2 MPS Design Drawings

Titanium anode wires are strategically installed into the structural floor slab both in the Theatre and the two Battery Rooms. Additionally, anodes was also installed on the walls of the battery rooms, refer to the layout presented in Appendices.

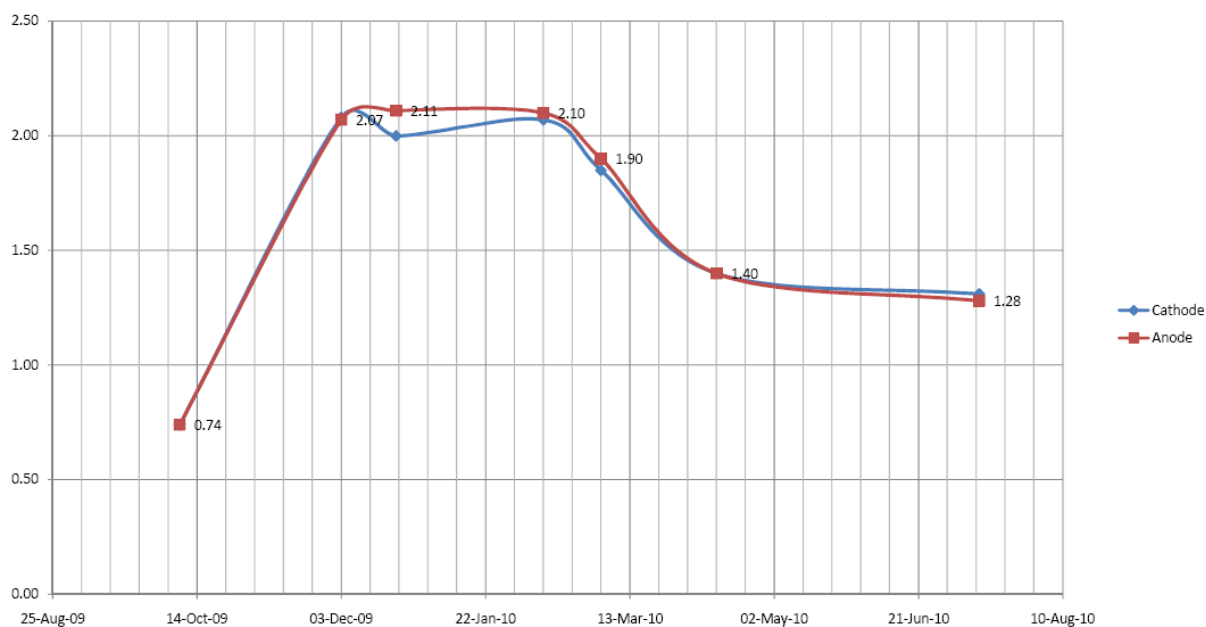
9.4 Electrical Current and RH Readings

Date of Commissioning :	8 Oct 09							
Date of site visit:	08-Oct-09	3-Dec-09	22-Dec-09	11-Feb-10	3-Mar-10	12-Apr-10	12-Jul-10	
Weather:	Fine & Dry	cool & dry	sunny	Sunny	Cloudy	Cloudy	Fine	
Temperature:	25 deg	21 deg	20.6	21 deg	20 deg	20 deg	29 deg	
LCD Reading:	9% - 10%	20%	20%	19%	19%	19%	18%	
No.	Anode - WALLS	Amps	Amps	Amps	Amps	Amps	Amps	Amps
1	ALL	0.74	2.07	2.11	2.10	1.90	1.40	1.28
2	All Wall	0.19	0.59	0.23	0.61	0.55	0.45	0.22
3	W1	0.60	0.90	0.09	0.73	0.68	0.45	0.39
4	W2	0.53	0.61	0.04	0.45	0.32	0.26	0.23
5	W3	0.32	0.30	0.03	0.25	0.22	0.15	0.11
6	W4	0.62	1.00	0.07	0.79	0.56	0.49	0.48
7	W5	0.53	0.51	0.04	0.42	0.34	0.24	0.21
8	W6	0.72	1.79	0.37	1.69	1.23	1.08	1.05
9	All F	0.47	1.26	1.71	1.31	1.23	0.95	1.08
10	F1	0.62	1.31	0.65	1.15	1.08	0.70	0.68
11	F2	0.72	1.44	0.81	1.26	1.05	0.82	0.80
12	F3	0.71	1.83	1.45	1.80	1.48	1.12	1.02
13	F4	0.77	1.98	1.55	1.89	1.69	1.17	1.13
14	F5	0.50	0.59	0.18	0.45	0.37	0.26	0.23

Cathode							
15	ALL C	0.74	2.08	2.00	2.07	1.85	1.40	1.31
16	C1	0.22	0.55	0.58	0.56	0.48	0.43	0.38
17	C2	0.17	0.94	0.70	1.00	0.88	0.75	0.68
18	C3	0.44	0.87	0.82	0.77	0.64	0.54	0.53
	Reading taken by:	EC	EC	JC	EC	EC	EC	EC

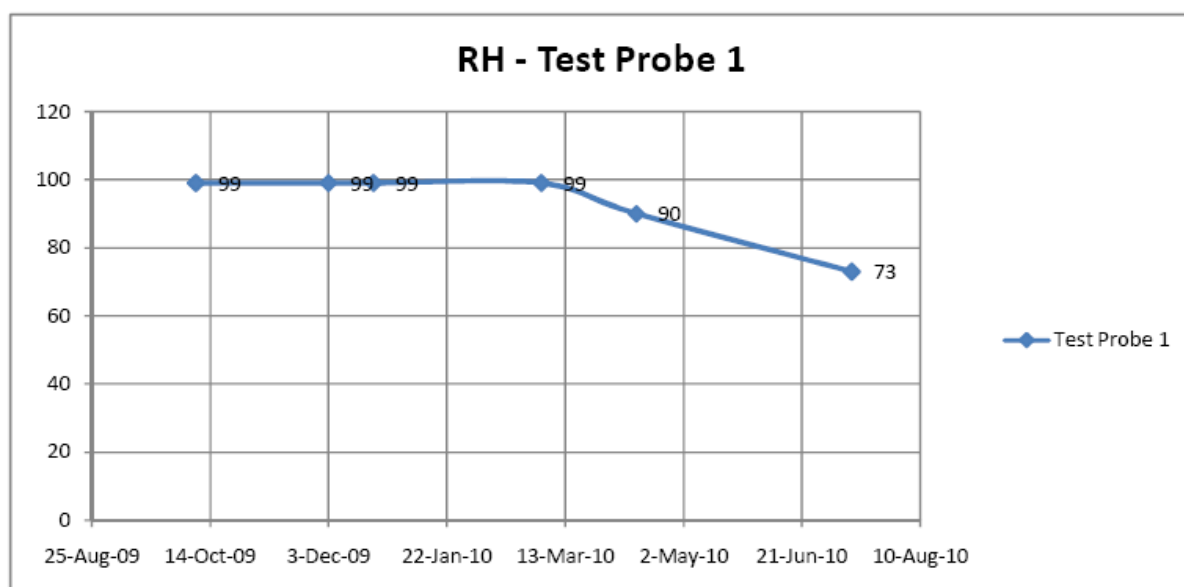
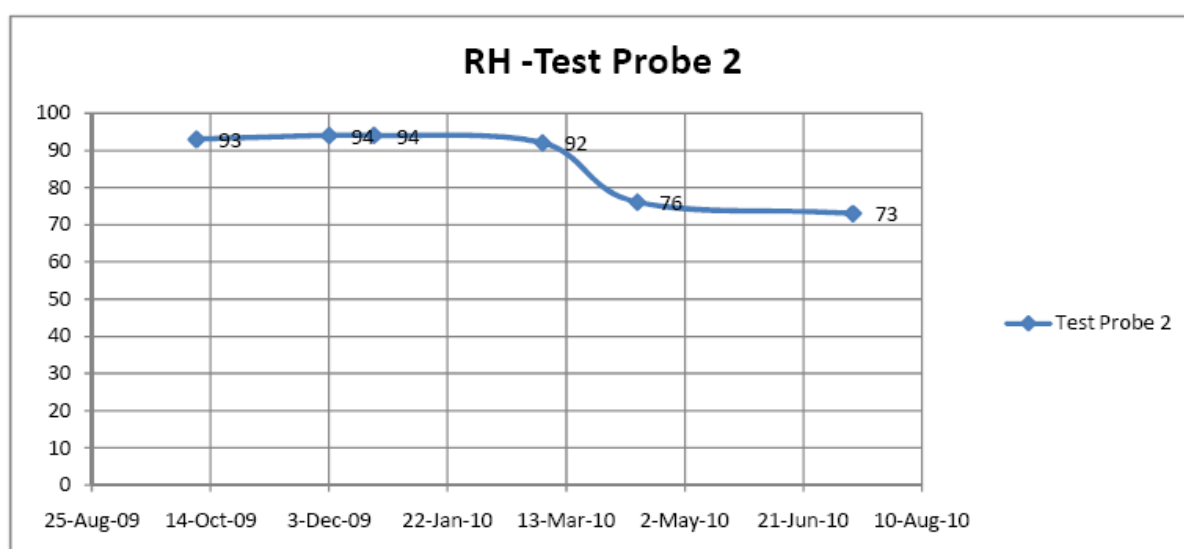
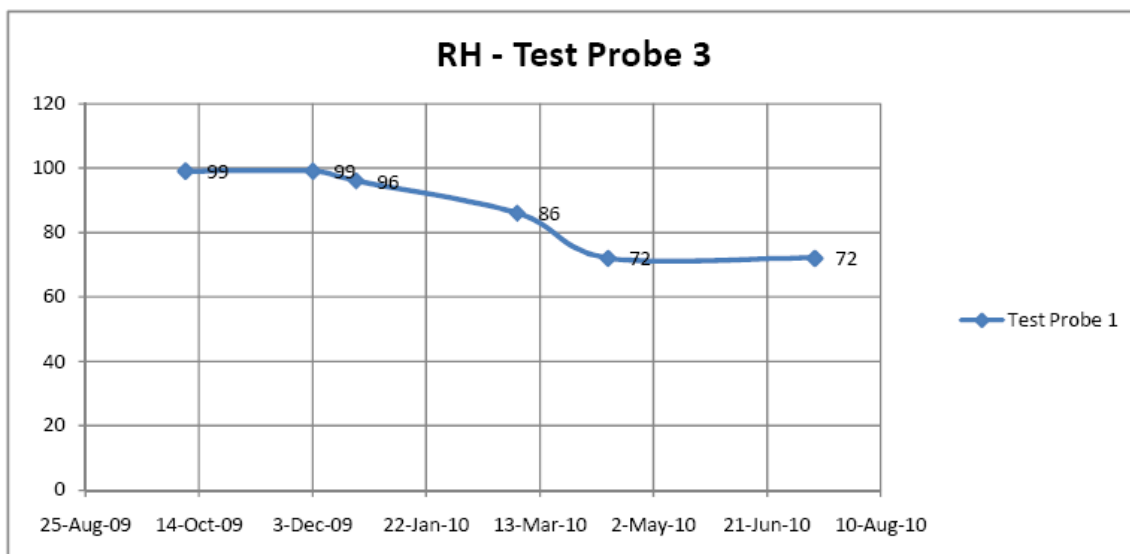
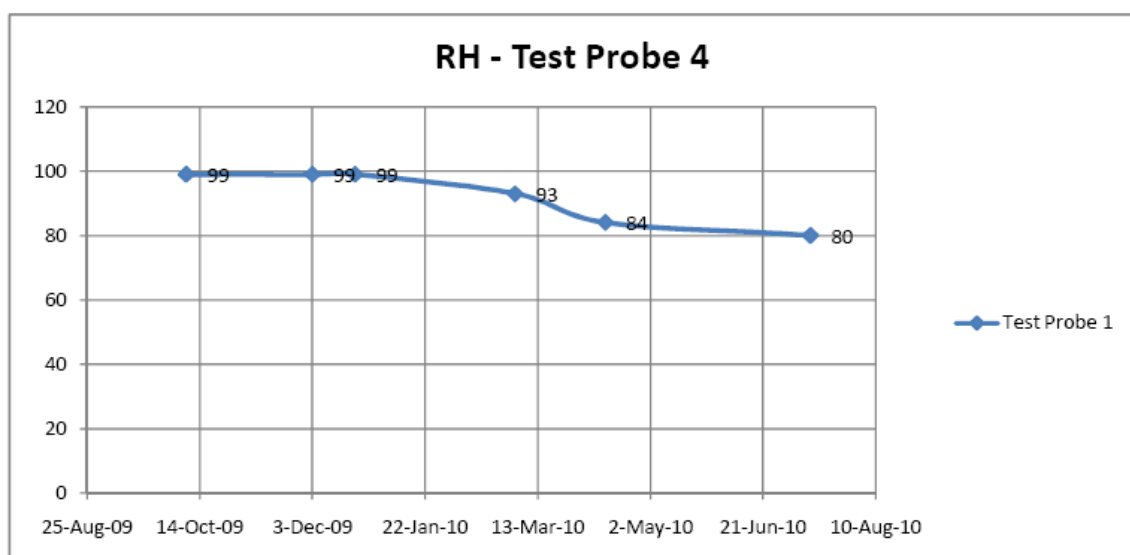
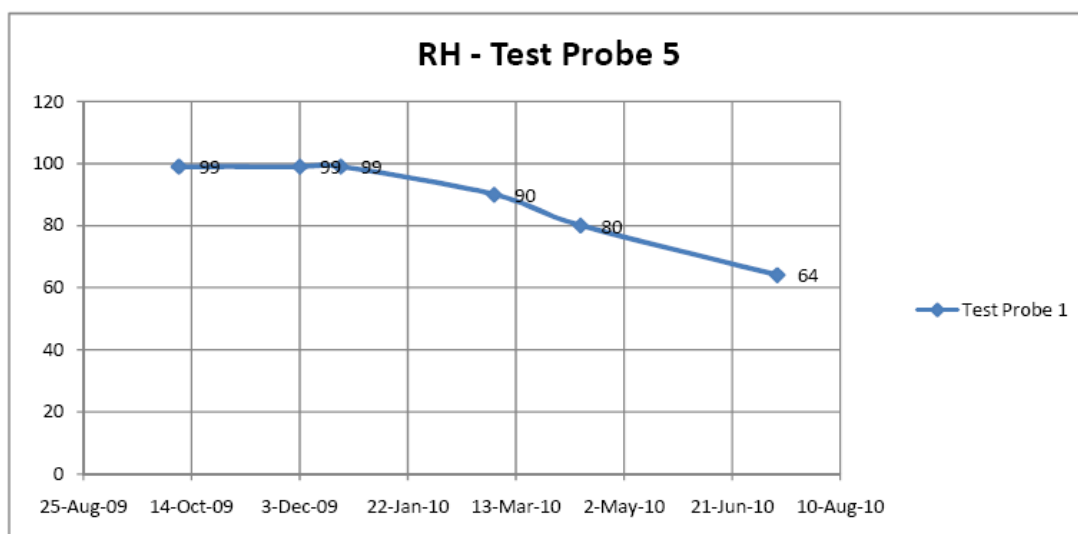
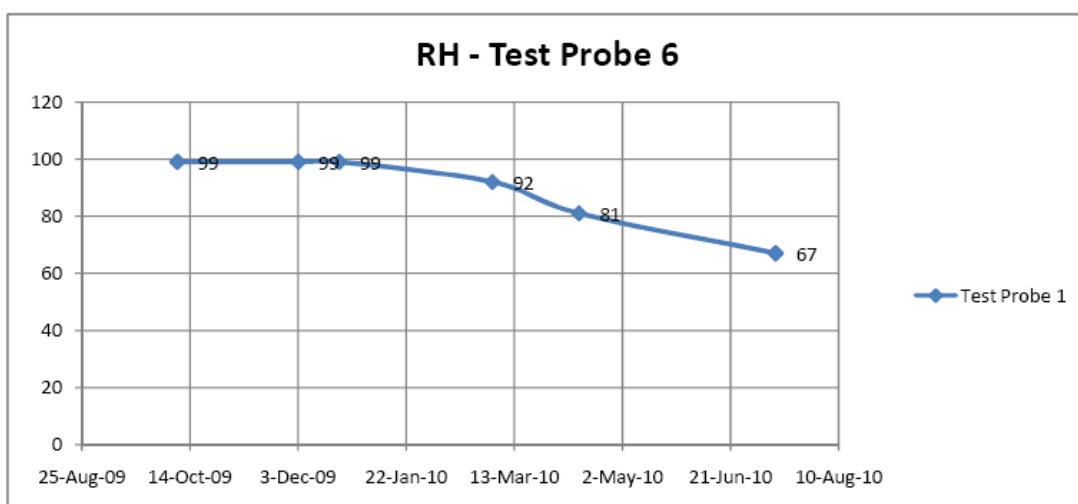
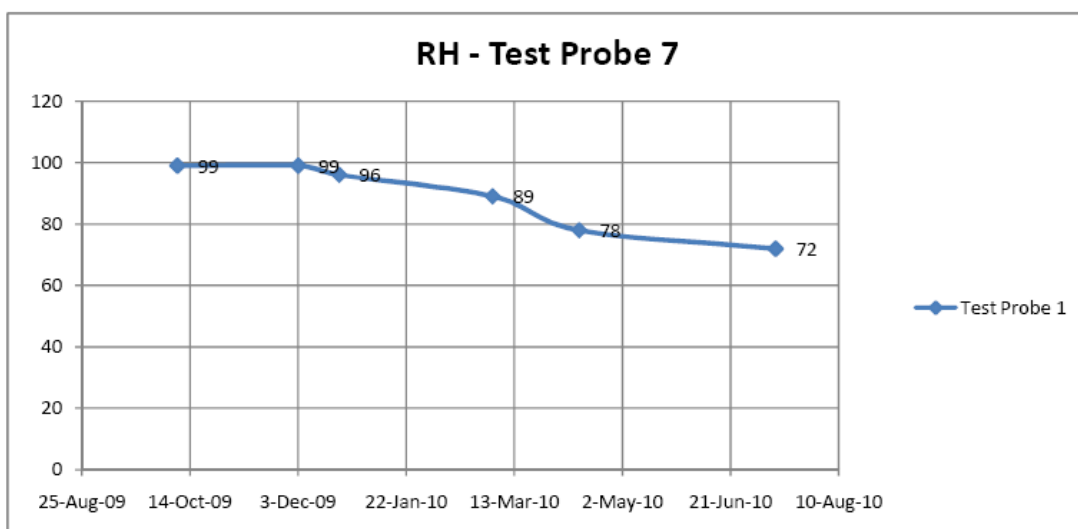
9.5 Relative Humidity (RH) Readings

Based on the results of the Relative Humidity (RH) readings; the lowest RH levels recorded is 64% and the highest is 80% which is below the level set-forth in the BS Standard (BS 6150:2006 Table 16).

8-Oct-09	3-Dec-09	22-Dec-09	3-Mar-10	12-Apr-10	12-Jul-10
Test Probe 1	99	99	99	99	90	73
Test Probe 2	93	94	94	92	76	73
Test Probe 3	99	99	96	86	72	72
Test Probe 4	99	99	99	93	84	80
Test Probe 5	99	99	99	90	80	64
Test Probe 6	99	99	99	92	81	67
Test Probe 7	99	99	96	89	78	72

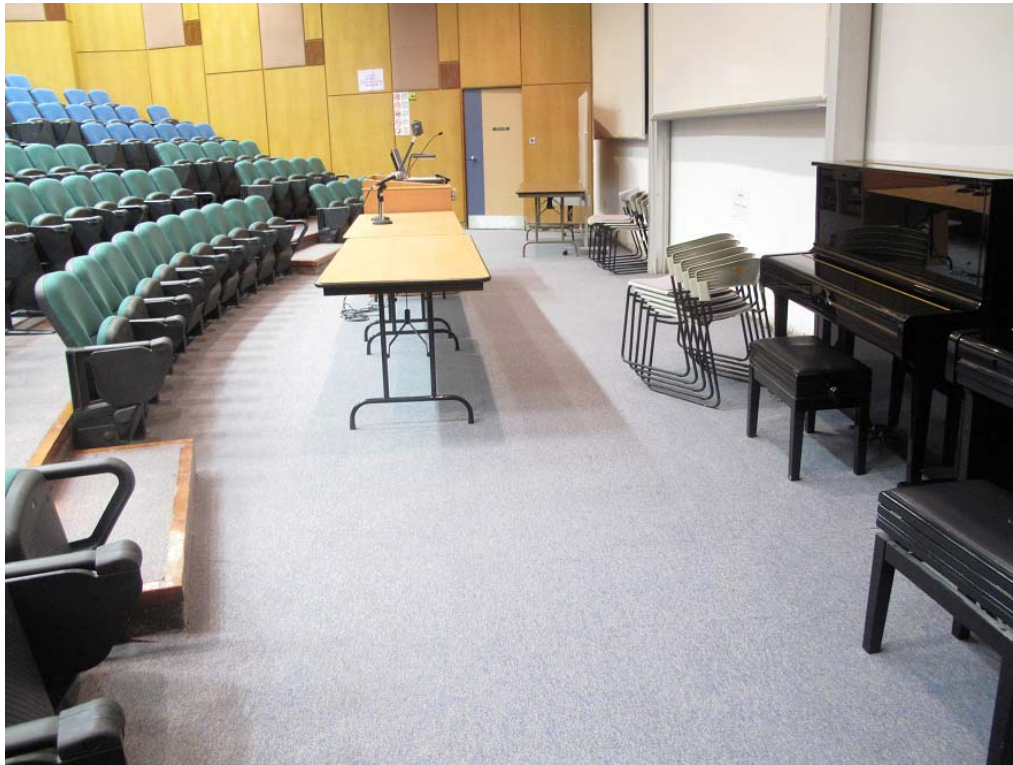
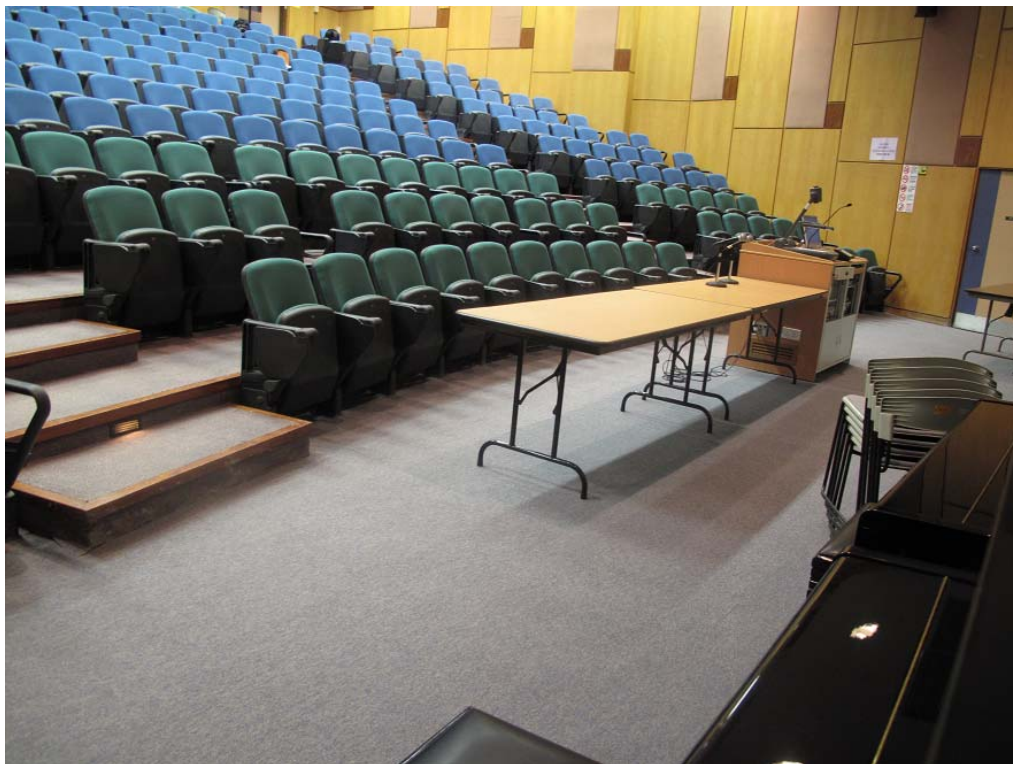
The Lecture Theatre is in a very Dry Condition

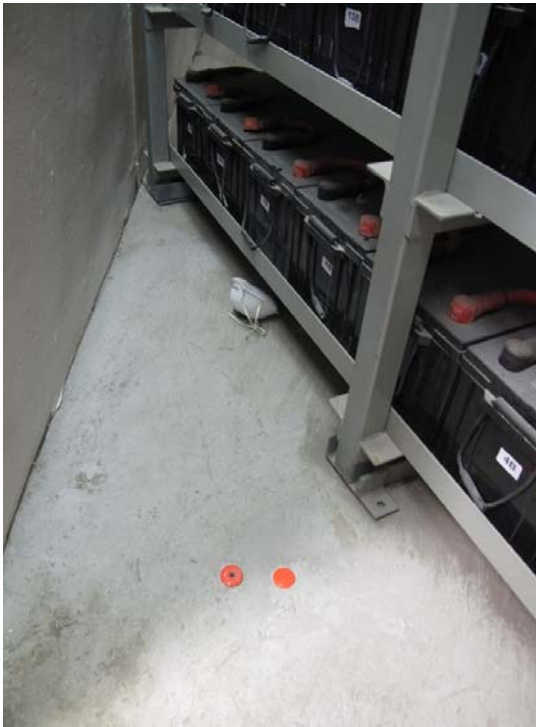
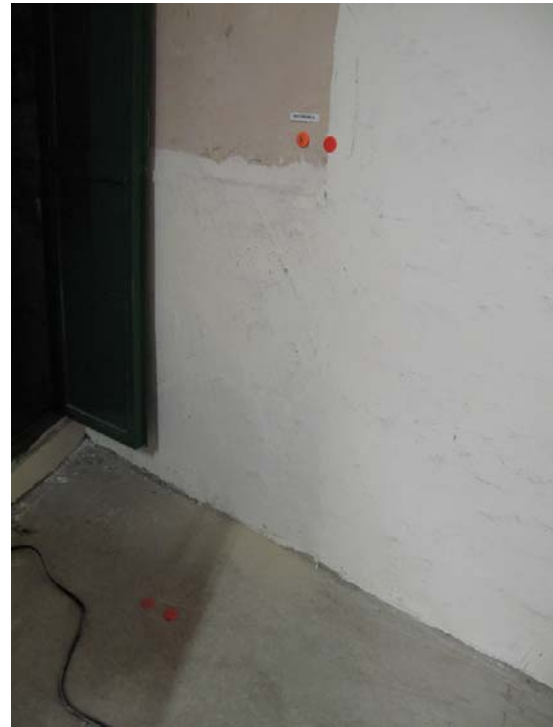
Both Battery Rooms 1 & 2 are in a very Dry Condition

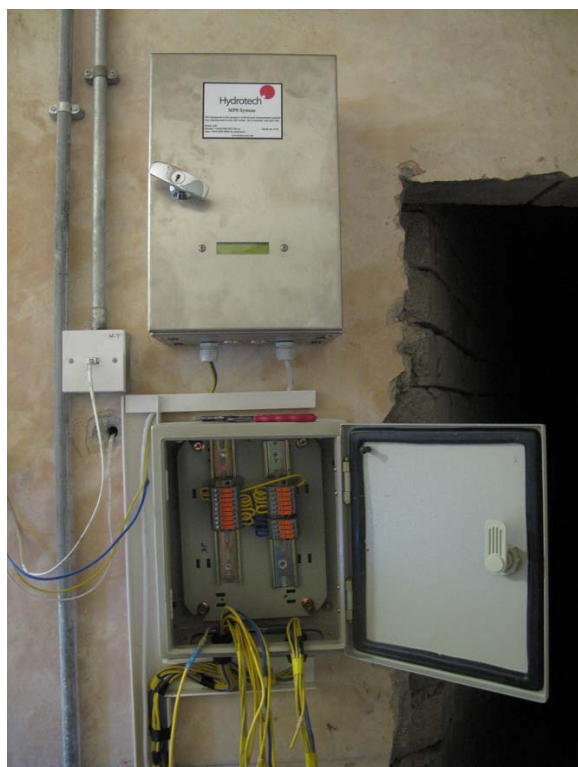
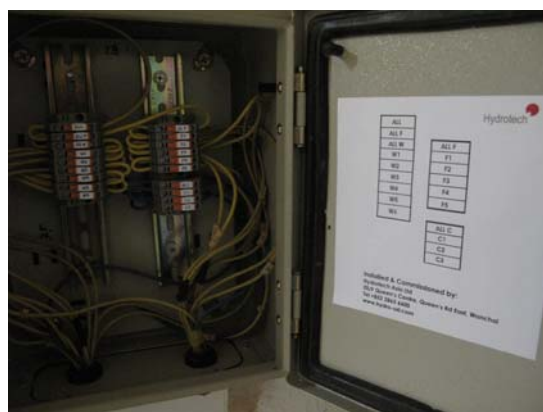
Photo No. 1A, MPS Control Unit & junction box installed in Battery Room 2

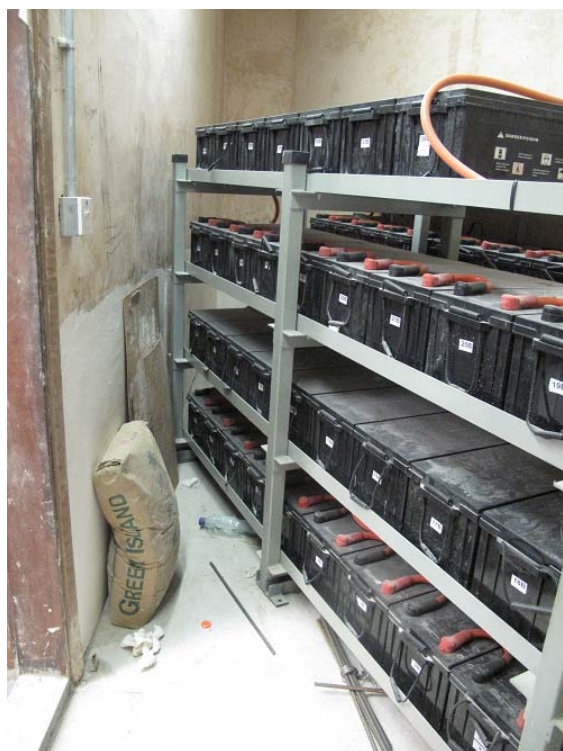
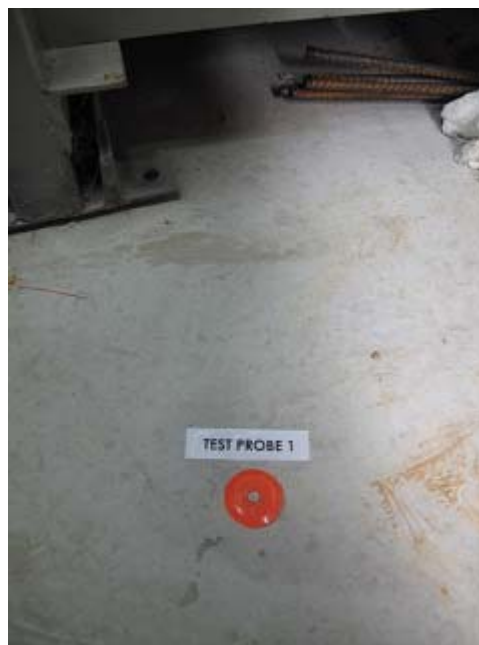
Photo No. 1, Test Probe 1 – Installed on floor located at Battery Room 1

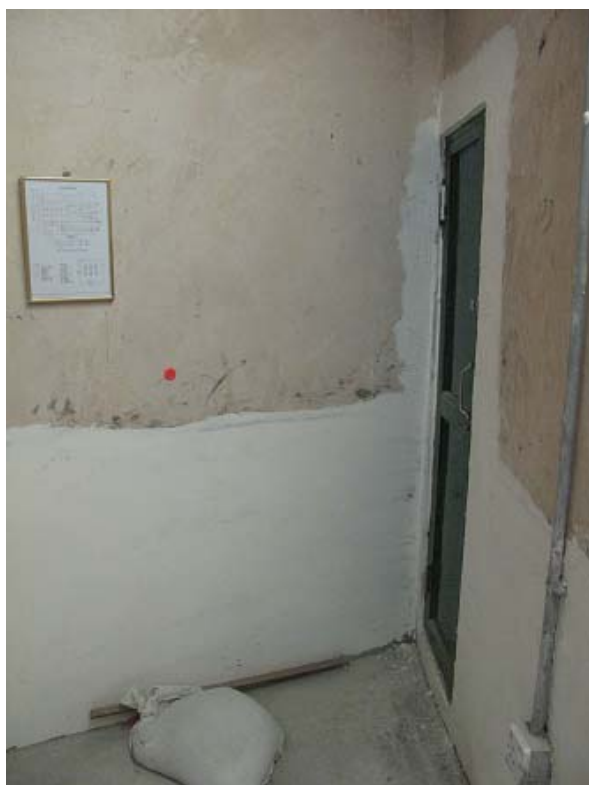
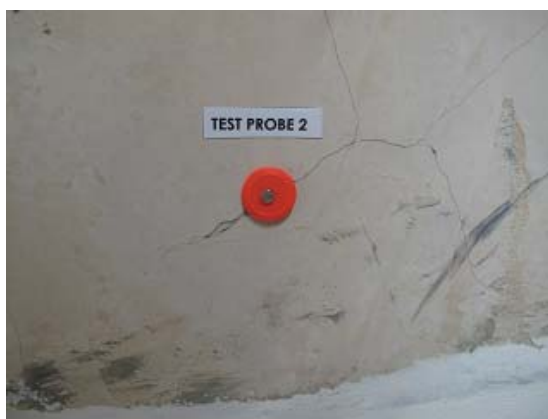
Photo No. 2, Test Probe 2 – Installed on wall located at Battery Room 1

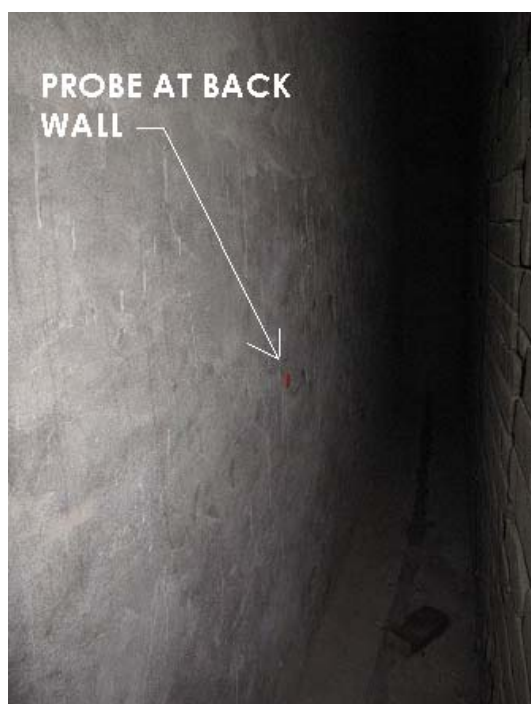
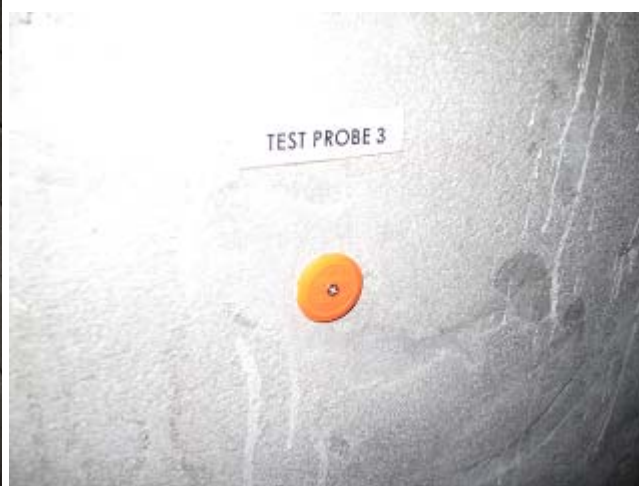
Photo No. 3, Test Probe 3 – Installed at the back of block wall located at Battery Room 1

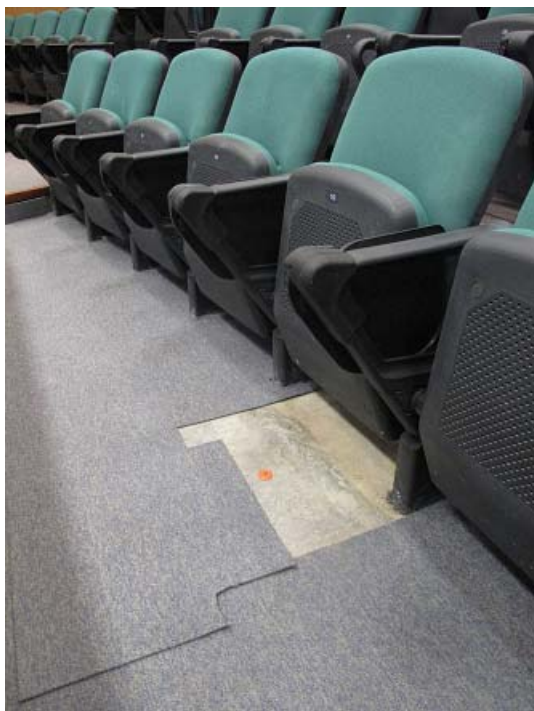
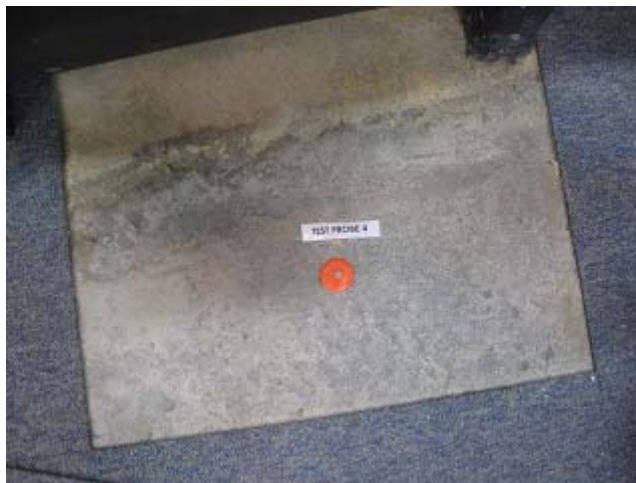
Photo No. 4, Test Probe 4 – Installed at the floor slab of the lecture theatre

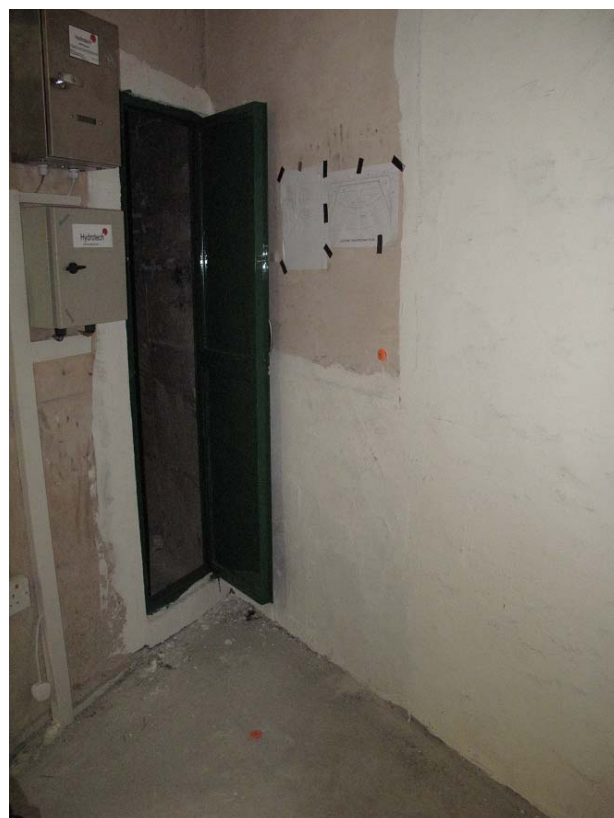
Photo No. 5, Test Probe 5 – Installed at the floor slab of Battery Room 2

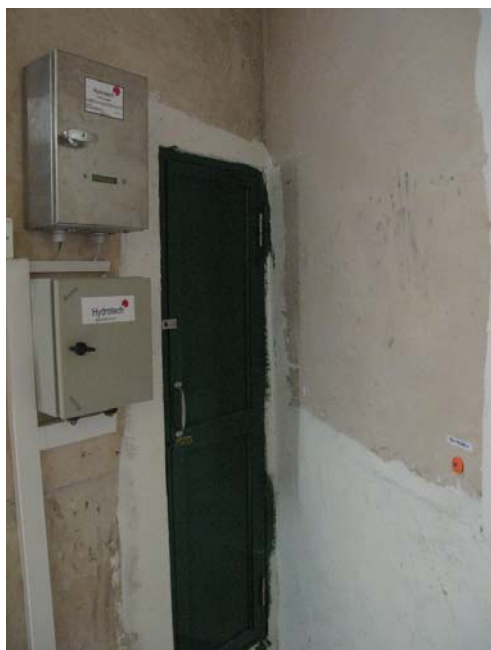
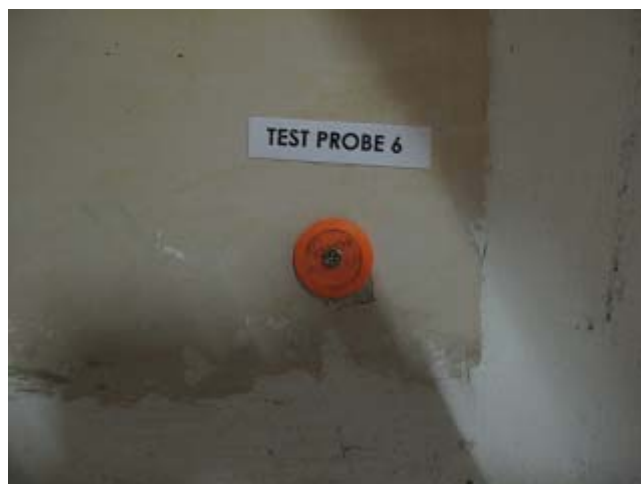
Photo No. 6, Test Probe 6 – Installed at the wall of Battery Room 2

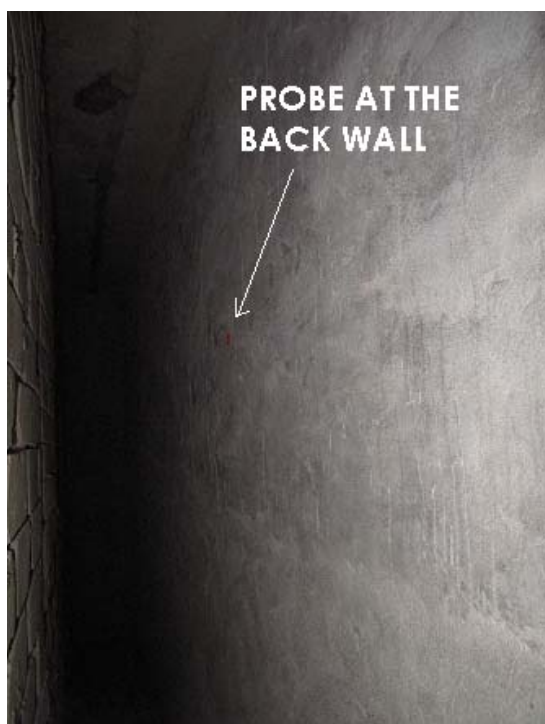
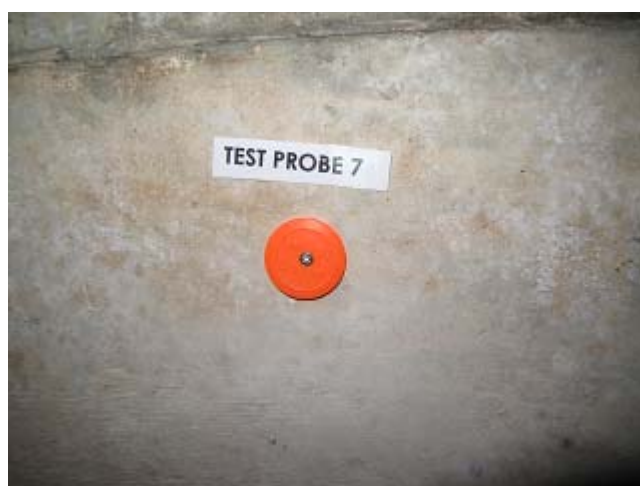
Photo No. 7, Test Probe 7 – Installed at the back of block wall located at Battery Room 2

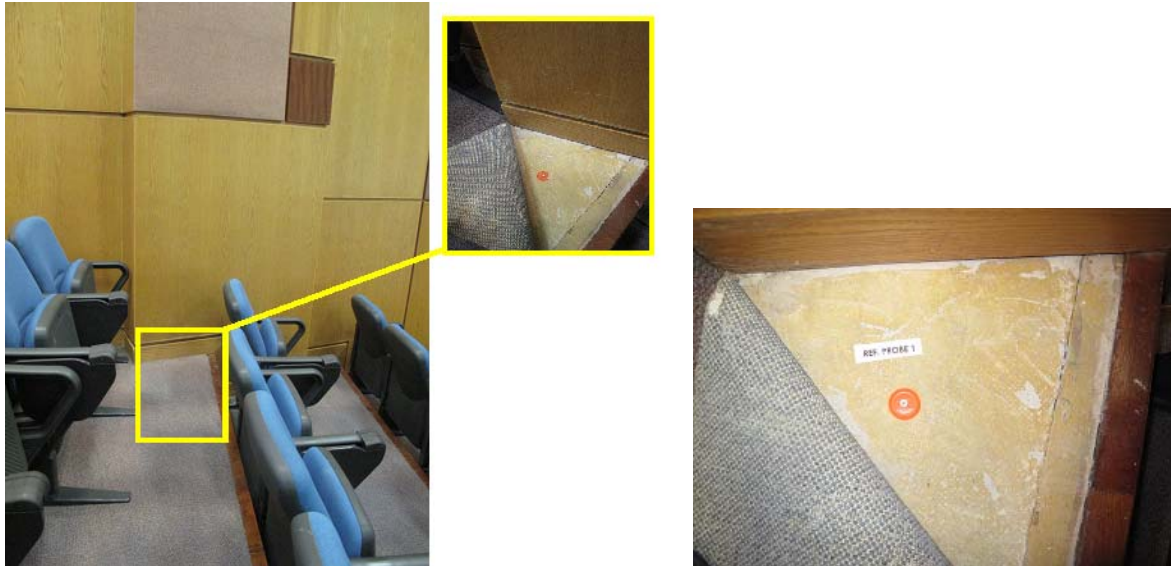
Photo No. 8, Reference Probe 1 – Installed at the floor slab of the lecture theatre

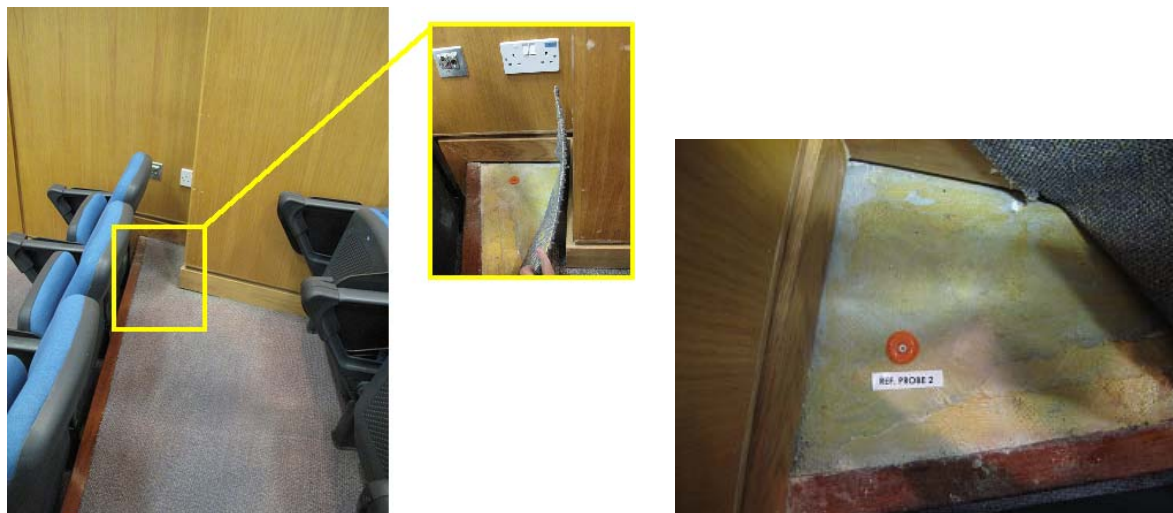
Photo No. 9, Reference Probe 2 – Installed at the floor slab of the lecture theatre
