**MPS System Installation
at CLP Fan Room No. 4
Harbour City, No. 25 Canton Road
Tsim Sha Tsui, HK**

Prepared by:
Great Top Engineering Limited
Flat 5, 6/F Shiu Fat Industrial Building
139-141 Wai Yip Street, Kwun Tong
Tel (852) 2345 2219
Fax (852) 2345 2259

March 2011

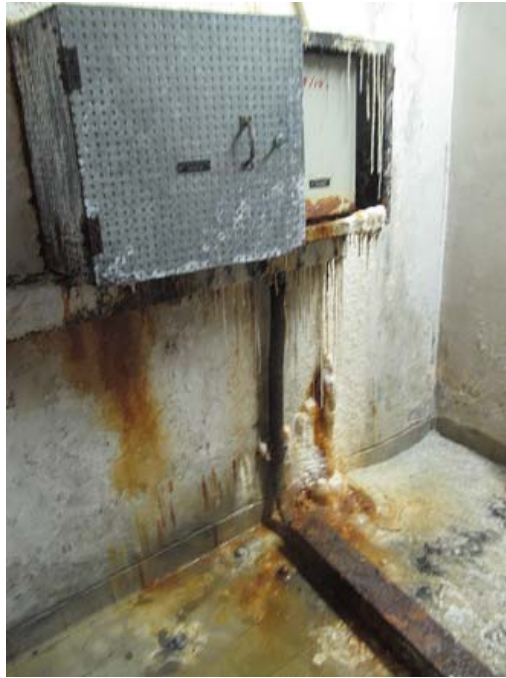
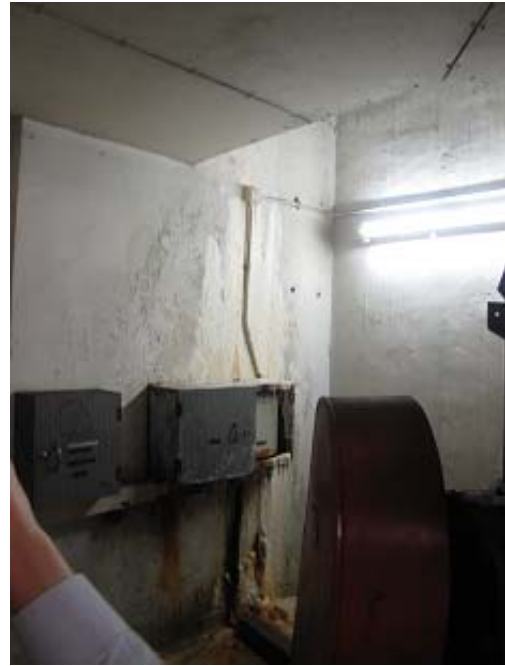
Visible water ingress was noticed on the existing 600mm thick diaphragm wall. Efflorescence was evident on walls.

Conditions of external diaphragm wall

Based on the site condition survey, it was concluded that MPS system will be install on the tiled floor slab by saw cutting a deeper groove to allow the anode to be placed onto a sound screeding layer.

Titanium anode wires are strategically installed into all external diaphragm walls and selected internal walls where peeling of paint was observed.

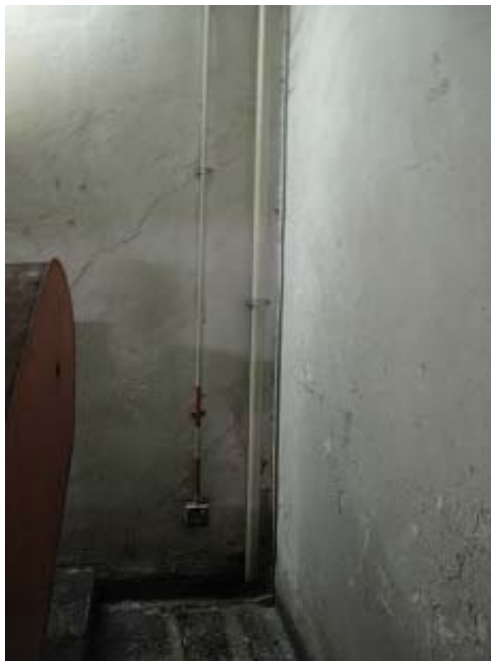
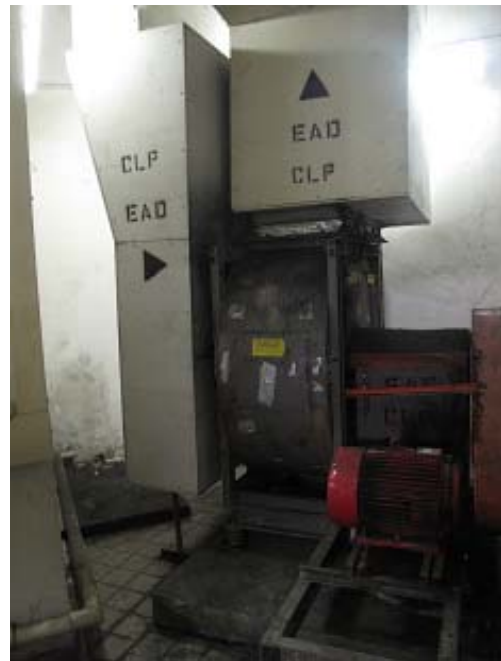
Visible cracks appeared on the surface of the internal walls, peeling of paints was also noticed in some locations.

Conditions of internal wall and existing equipment

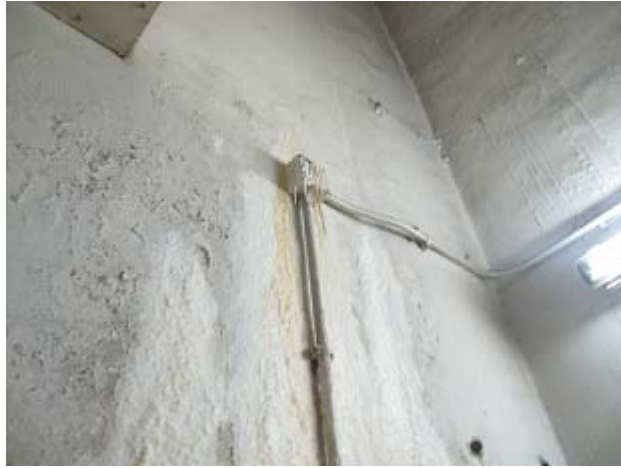
Efflorescence of walls

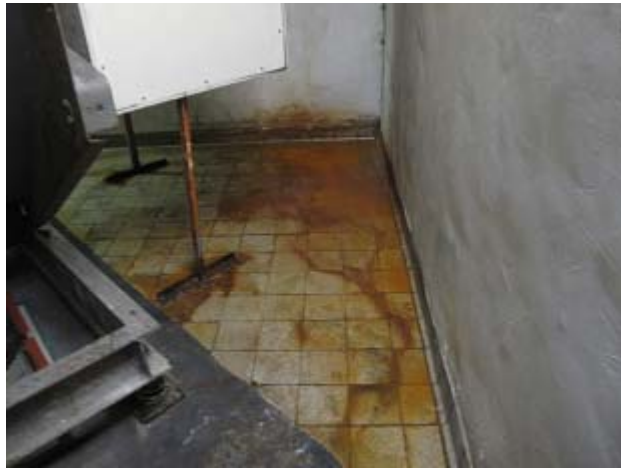
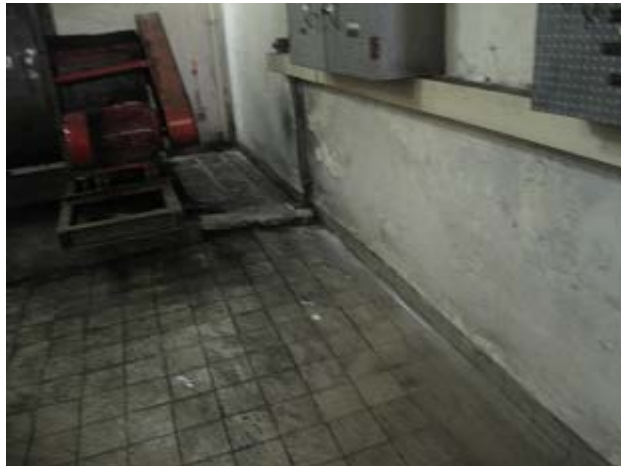
The CLP Fan Room is adjacent to Victoria Harbour and suffers from severe water ingress on walls and floor slab through the body of the concrete lining.

Conditions of existing floor slab

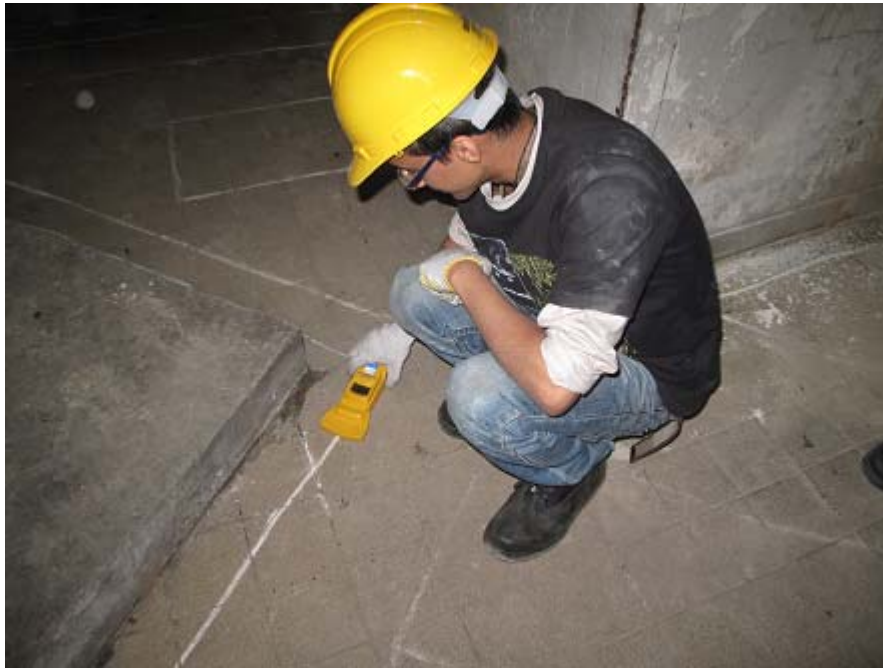
Setting out and cover meter survey

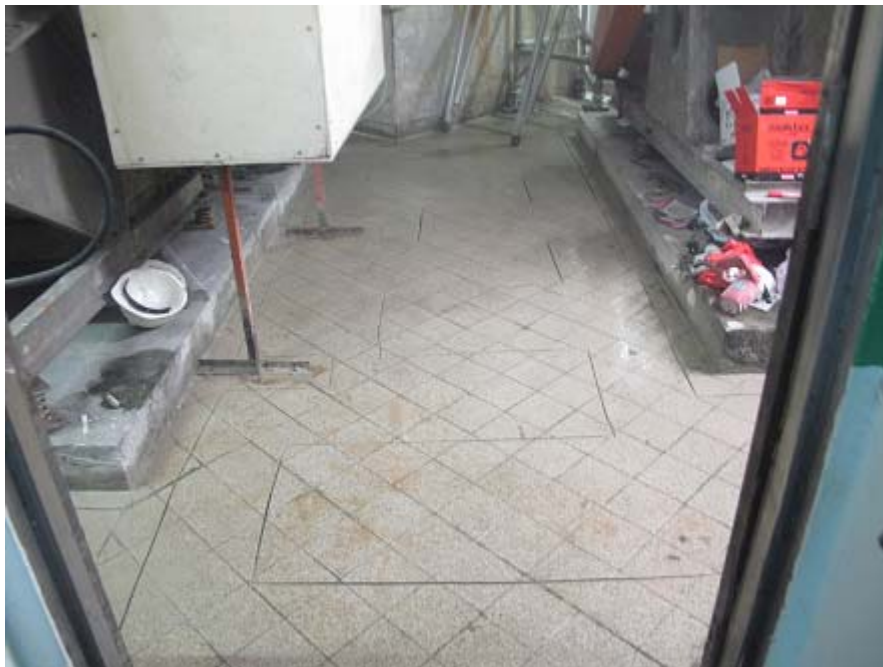
Saw cutting works on floor slab

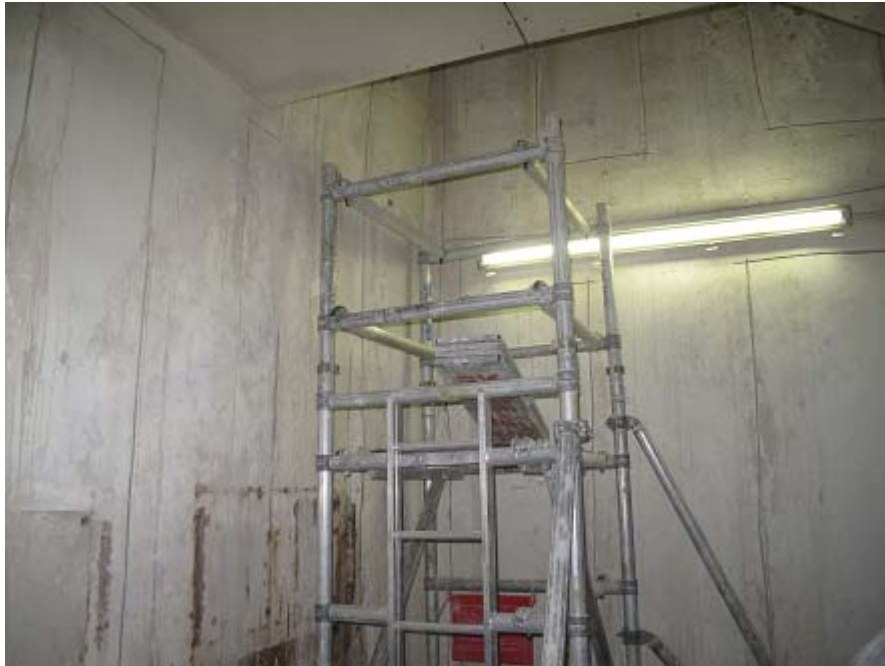
Saw cutting works on walls

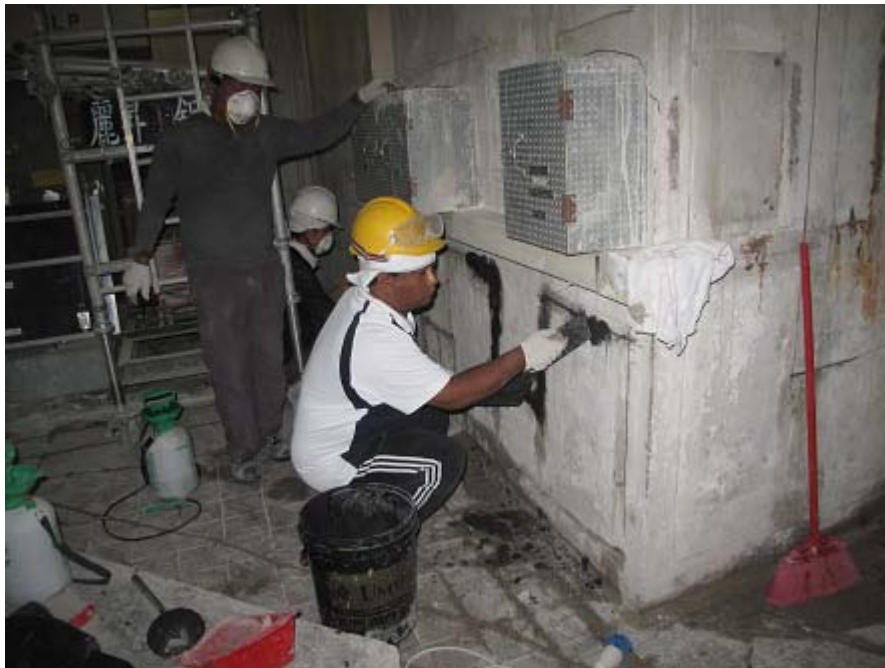
Installation of titanium anode wires and grouting works

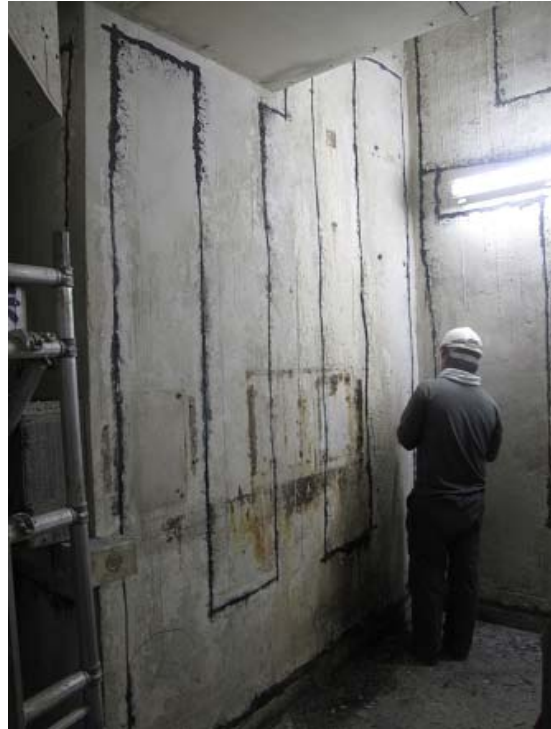
Installation of titanium anode wires and grouting works

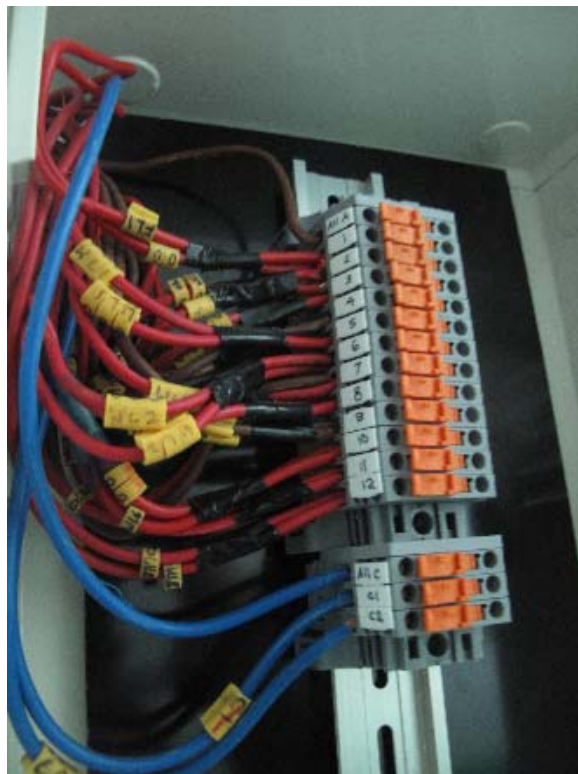
Installation of feeder wires and junction box

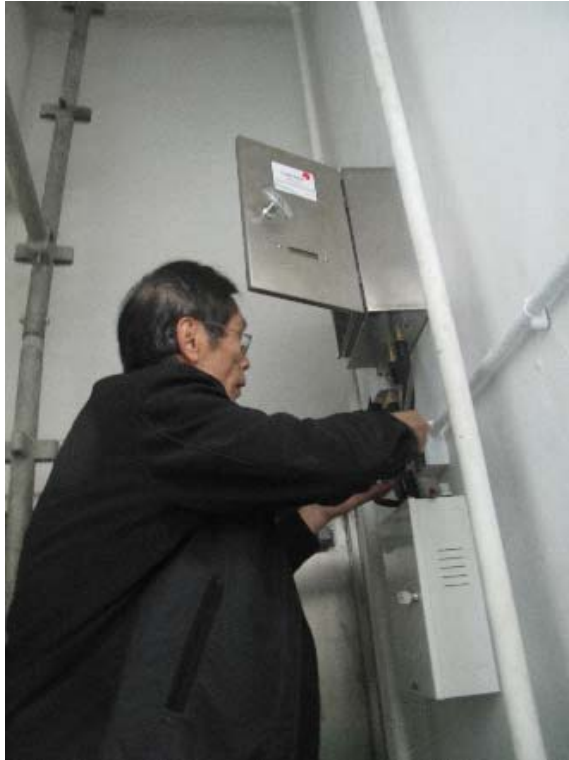
Installation of MPS Control Units

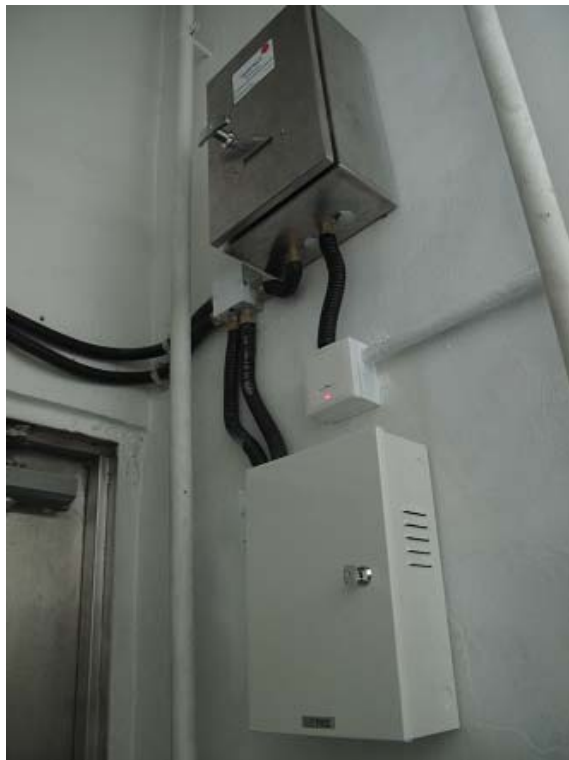
Completed Installation
