Orange Bastion Vault 1. Gibraltar

AOP System

Summary: Vault 1

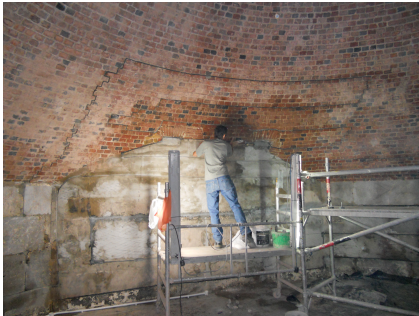
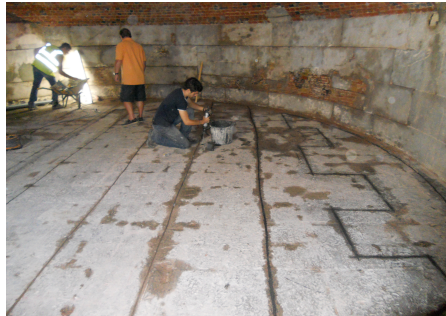
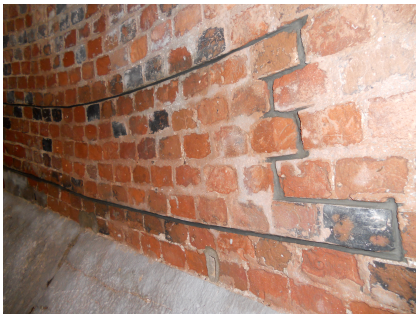
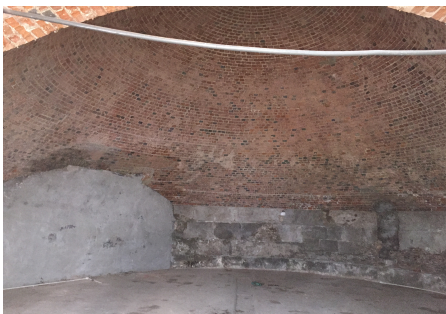
Orange Bastion Is an over 250 year old military structure. It forms part of Gibraltar's history and culture. The most important aspect of our installation is, it must look as though we were never there, all cuts and chases must be within the existing grout lines and there must be no lasting damage whatsoever. The vault is a domed room with a 40 foot diameter and a height of over 40 feet. The water ingress problem was two fold; the water table is virtually the same height as the floor and the walls were extremely damp due to the backfill being ballistic sand and rubble. The Government Heritage office was very keen to preserve the originality of the vault, whilst curing the chronic ingress problem.

Success Criteria: The floor was not original it was more recent concrete, which at certain times of the year could flood to over 12 inches. Causing extensive dampness in the old brickwork.

Orange Bastion Vault 1 dates back to 1750 and is of great historic and cultural importance. The construction is a domed room thought once to be the mechanical power source for a large gun placed above the structure. The construction is virtually all red brick with superb symmetry. The brick size is approximately 8 inches by 3 inches. All the anode placement had to be within the grout line which meant every chase had to be cut by hand. There was no way of knowing exactly how thick the walls are or what is hidden behind and as no accurate drawing exist, much of what was done was based on experience rather than engineering.

There are three cathodes, two to the north side and one to the south

The installation used 2mm grade 1 titanium wire and the cathodes are copper covered steel 1.2 metre probes. The feeder cables are 1.5 mm and 4 mm respectively. One AOP Pulse box is fitted.

Once installed and fully operational, the system dried the floor and walls and no flooding in vault 1 has been reported in over 7 years.

When it came to reinstating the grout and any damaged bricks, PCL used the original grout to match the colours exactly, that included using a ground brick to make sure the heritage was not lost.

All the civil works were undertaken by PCL, including the electrical and connection of the anodes and cathodes.

The outcome is 100% successful, in terms of stopping the water ingress also in terms of the buildings aesthetics.
