Park West, UK Case Study

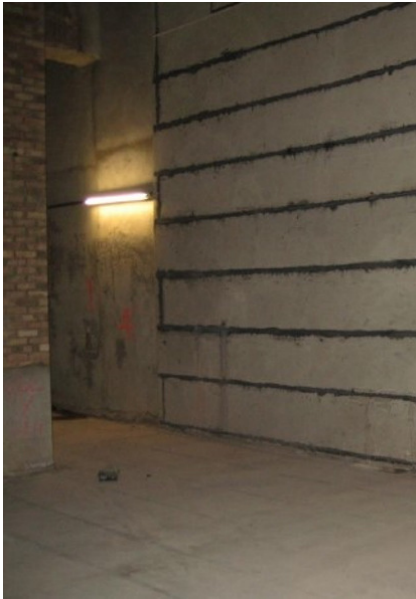
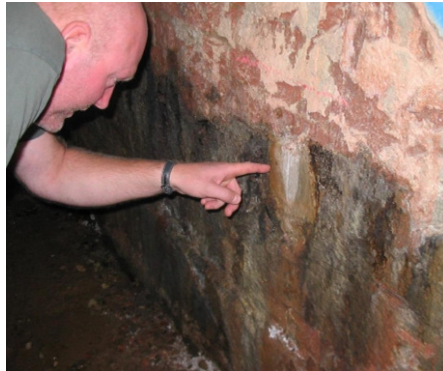
A large amounts of mechanical cracks were found and part of the wall were right out deteriorated. There were water running out of walls and on the floor. The asset management wanted a trial installation to see what could be done and then later decide if they want a full scale installation. It all depended on if they come to need the basement area in the future.

We made a trench to guide the water coming from outside of the trial area, to the other end of the basement. This was to ensure that the target area would not be compromised by water coming from elsewhere. This is how much water ingress this basement had. The target floor was solid concrete and perfect for the MPS installation and was done in regular manner. The target wall was heavily deteriorated and water came running down its face. It was a brick wall, but a waterproofing company some 15 years earlier had tried to cover it with a concrete slab without success. In our design decisions, we felt we needed to add a 50mm concrete slab on the wall as it was completely deteriorated. We placed the anode lines in the new slab. We did not repair or inject any of the mechanical cracks behind the new slab.

The floor had undergone an ordinary MPS installation and reached 89% RH within 8 weeks. The wall had a new concrete slab and was dry after the concrete had cured. Without the MPS system, the concrete slab would have been saturated within 1 week. The humidity test we did after 3 months showed a relative humidity of 90% in the slab. We drilled a 18mm hole about 30cm into the wall through the slab and the water flushed several meters into the room. Thus shows that this building is experiencing massive hydraulic water pressure and the MPS can withstand it hands down. After 12 months we made another RH test and the wall and floor was still below dry paint requirement of 92%RH, as it still showed 90%RH. Despite all the cracks behind the new 50mm slab, it showed that such a small concrete membrane with MPS, is sufficient to stop this high water pressure.
